DEPARTMENT OF TRANSPORTATION

Federal Aviation Administration

[Docket No. FAA-2020-0098; Product Identifier 2020-NM-011-AD; Amendment 39-19844; AD 2020-03-20]

Airworthiness Directives; The Boeing Company Airplanes

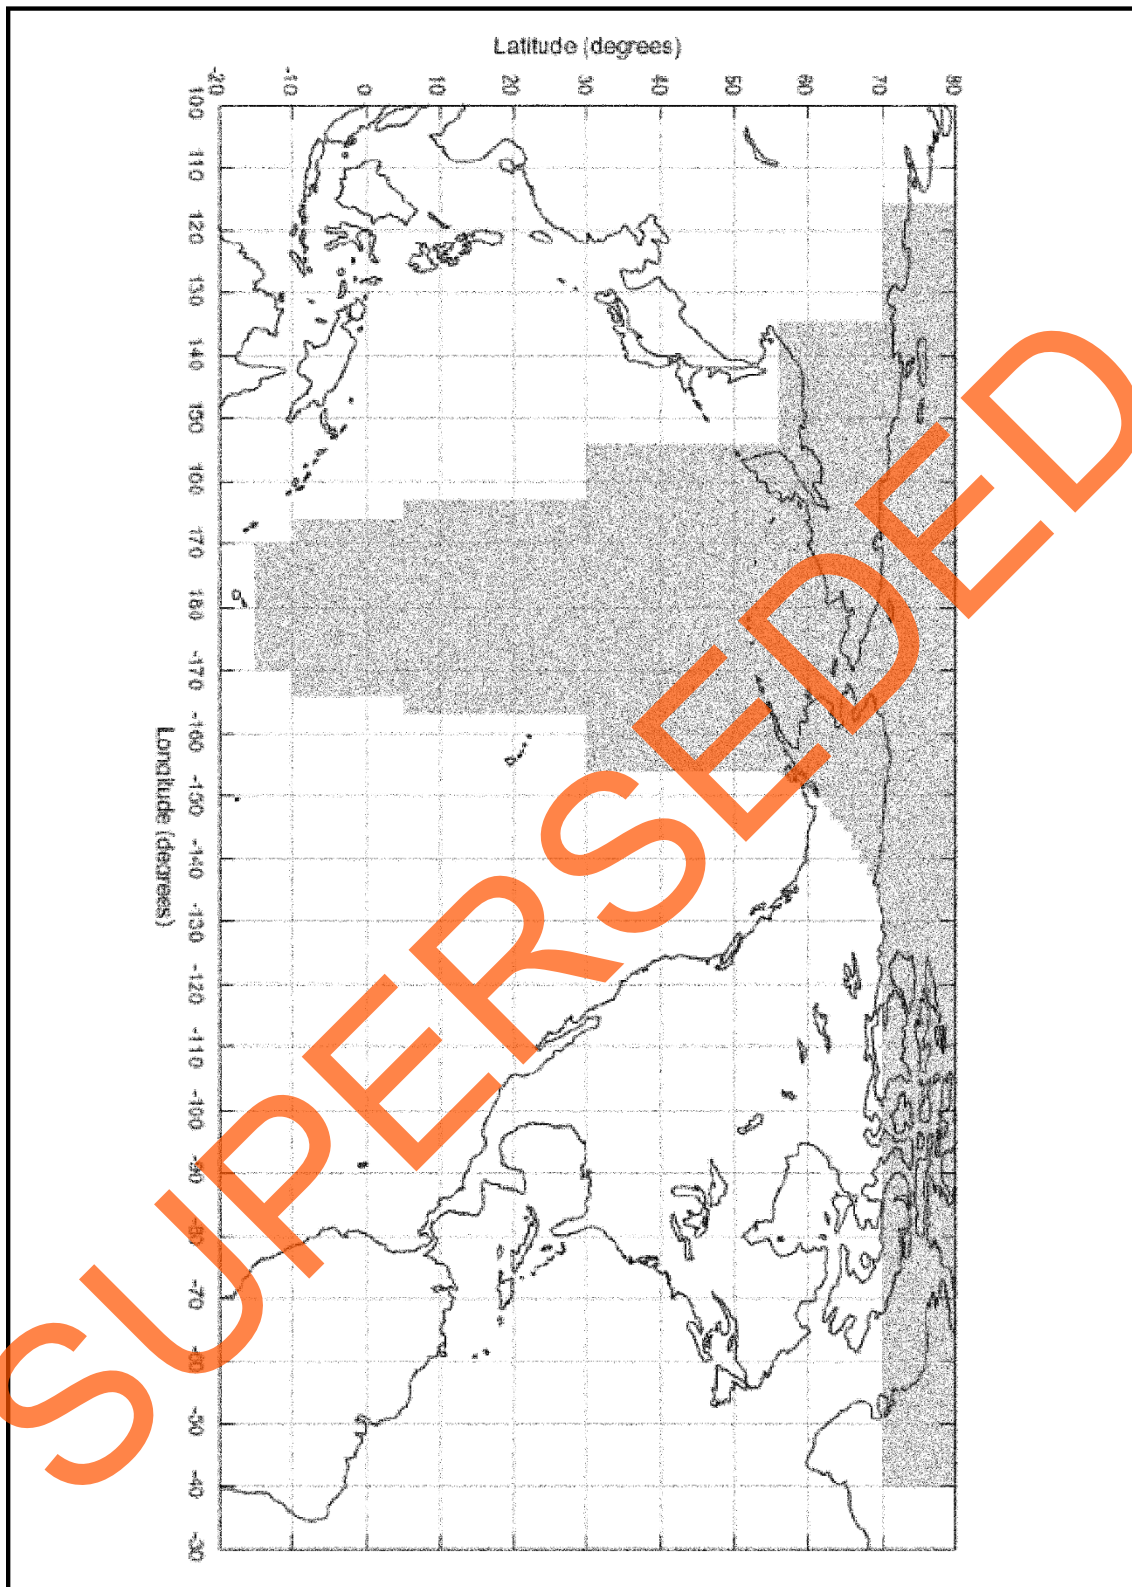
Figure 2 to paragraph (g) – AFM – Limitations or Certificate Limitations continued

Operations that require less than 0.3 RNP (For example, 0.1, 0.11, 0.15, etc.) in the region identified below are prohibited with GLU-2100 OPS software number COL4D-0087-0002, COL4E-0087-0001, COL48-0087-0700, or COL49-0087-0701 installed.

Region bounded by the following coordinates:

Latitude Range (degrees)	Longitude Range (degrees)
80 N to 70 N	40 E to 40 W
70 N to 69 N	134.5 E to 134.38 W
69 N to 68 N	134.5 E to 137.28 W
68 N to 67 N	134.5 E to 139.50 W
67 N to 66 N	134.5 E to 141.58 W
66 N to 65 N	134.5 E to 144.23 W
65 N to 64 N	134.5 E to 145.48 W
64 N to 63 N	134.5 E to 146.44 W
63 N to 62 N	134.5 E to 148.33 W
62 N to 61 N	134.5 E to 149.50 W
61 N to 60 N	134.5 E to 150.35 W
60 N to 59 N	134.5 E to 151.00 W
59 N to 58 N	134.5 E to 151.40 W
58 N to 57 N	134.5 E to 152.62 W
57 N to 56 N	134.5 E to 153.42 W
56 N to 30 N	154 E to 154 W
30 N to 5 N	163 E to 163 W
5 N to 10 S	166 E to 166 W
10 S to 15 S	170 E to 170 W
