**AGÊNCIA NACIONAL DE AVIAÇÃO CIVIL - BRAZIL**

## **BRAZILIAN AIRWORTHINESS DIRECTIVE**

**AD No.: 2021-02-02**

**AD No. 2021-02-02 - YABORÃ / 39-1478.**

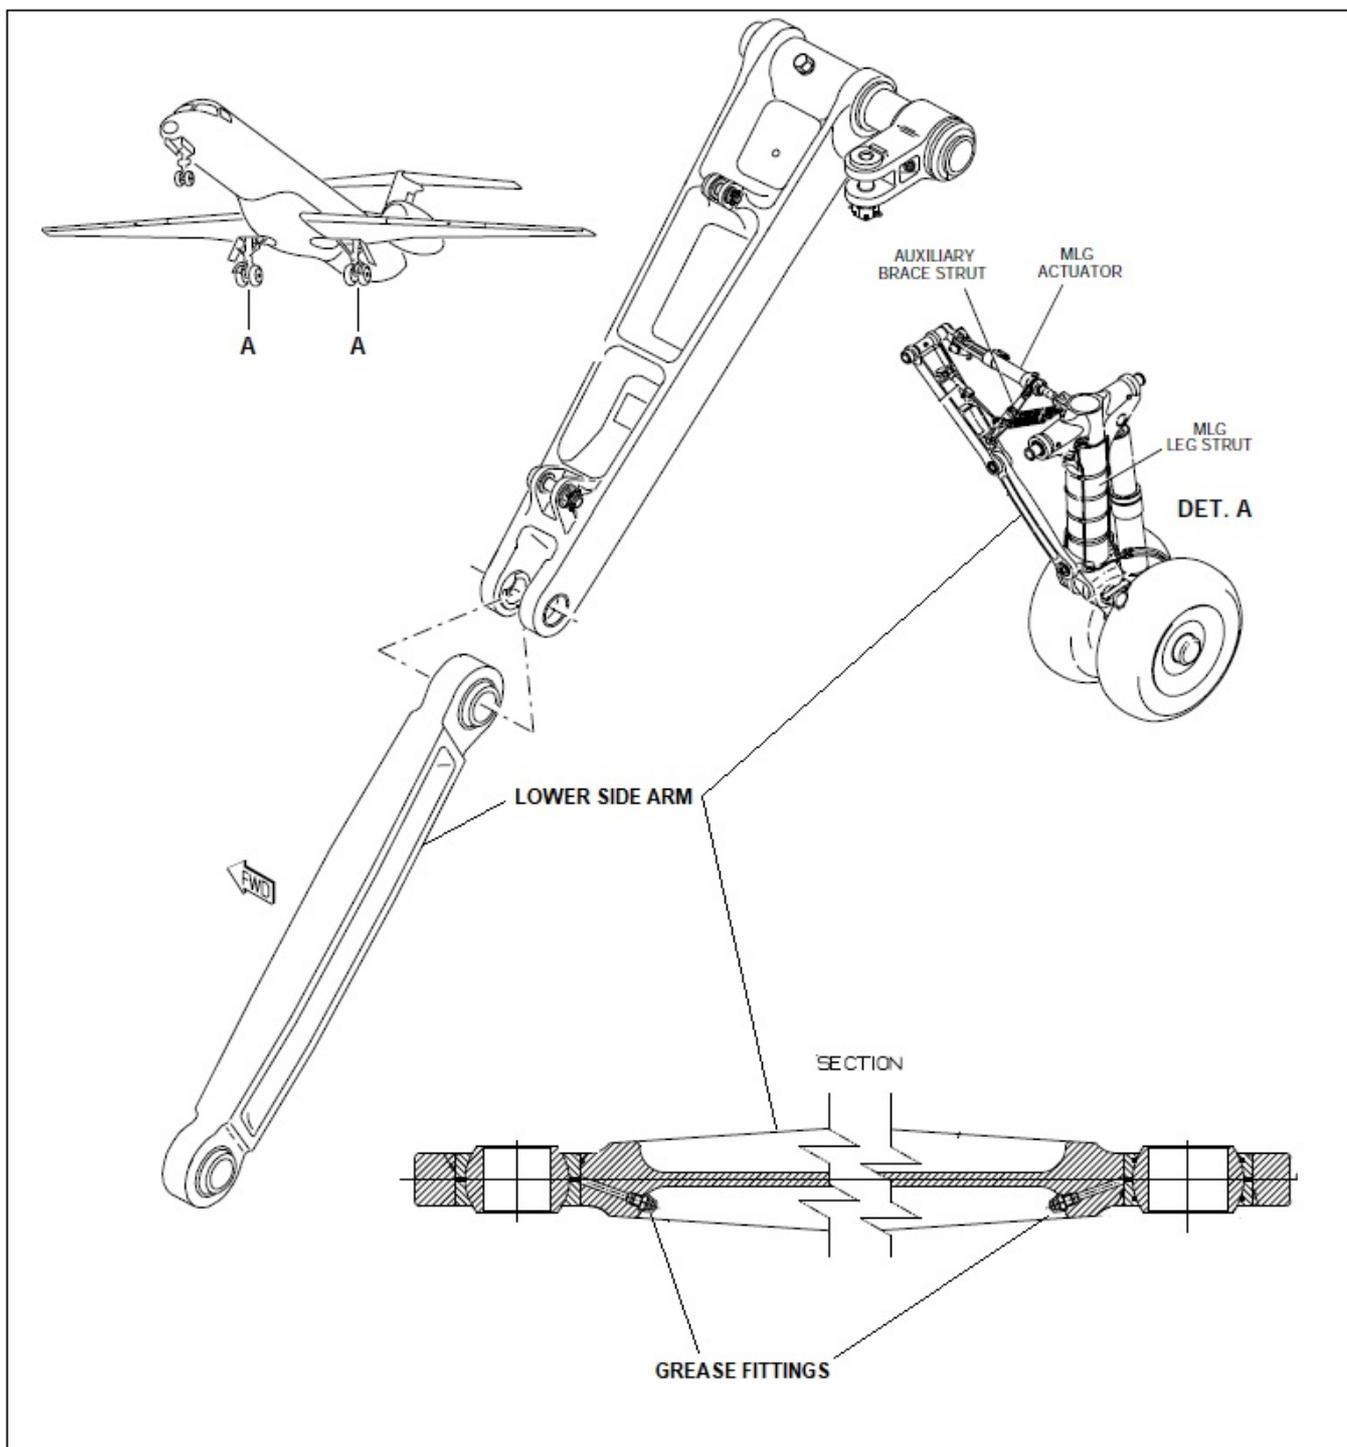
The inspection revealed one occurrence of an MLG Lower Side Arm installed on an aircraft possessing grease fittings on both of its sides. This is not an approved configuration as the MLG Lower Side Arm must have both of its grease fittings installed on the same side (see Figure 1 below).

Figure 1: MLG Lower Side Arm correct grease fittings installation

An MLG Lower Side Arm with grease fittings on both of its sides could lead to a misinterpretation of the MLG assembly instructions which could culminate in an inverted installation of the MLG Side Arm Strut Bearings since the grease fittings installation side on the Lower Side Arm are used as a reference to the correct installation of the Bearings.

A one-time inspection, and replacement of the MLG Lower Side Arm by a serviceable part (see NOTE 1), if necessary, as to the correct positioning of the grease fittings (see Figure 1).

NOTE 1: A serviceable MLG Lower Side Arm (P/Ns 2309-2510-501, or 2309-2510-503, or 2309-2510-505) is one that has both grease fittings installed on the same side of the part (see Figure 1).

1. Verify that both grease fittings are installed on the same side of the MLG Lower Side Arm and that both are facing the flight direction;
  - i. If, during the inspection required by item (a)(1) above, it is found that the grease fittings are installed on opposite sides of the MLG Lower Side Arm (one grease fitting on one side and the other on the opposite side), before the next flight (see NOTE 2), replace the MLG Lower Side Arm by a serviceable part (see NOTE 1). To comply with this paragraph, refer to procedure 32-10-03/400 (MAIN-LANDING-GEAR MAIN BRACE STRUT - REMOVAL/INSTALLATION) of the AMM applicable to the aircraft, and to the CMM (Component Maintenance Manual), procedure T.P. 145/1190\_32-10-03, as necessary;

- ii. If, during the inspection required by item (a)(1) above, it is found that both grease fittings are facing opposite to the flight direction, before the next flight (see NOTE 2), remove the Lower Side Arm and re-install it on the correct position (both grease fittings facing the flight direction – see Figure 1). To comply with this paragraph, refer to procedure 32-10-03/400 (MAIN-LANDING-GEAR MAIN BRACE STRUT - REMOVAL/INSTALLATION) of the AMM applicable to the aircraft, and to the CMM (Component Maintenance Manual), procedure T.P. 145/1190\_32-10-03, as necessary.

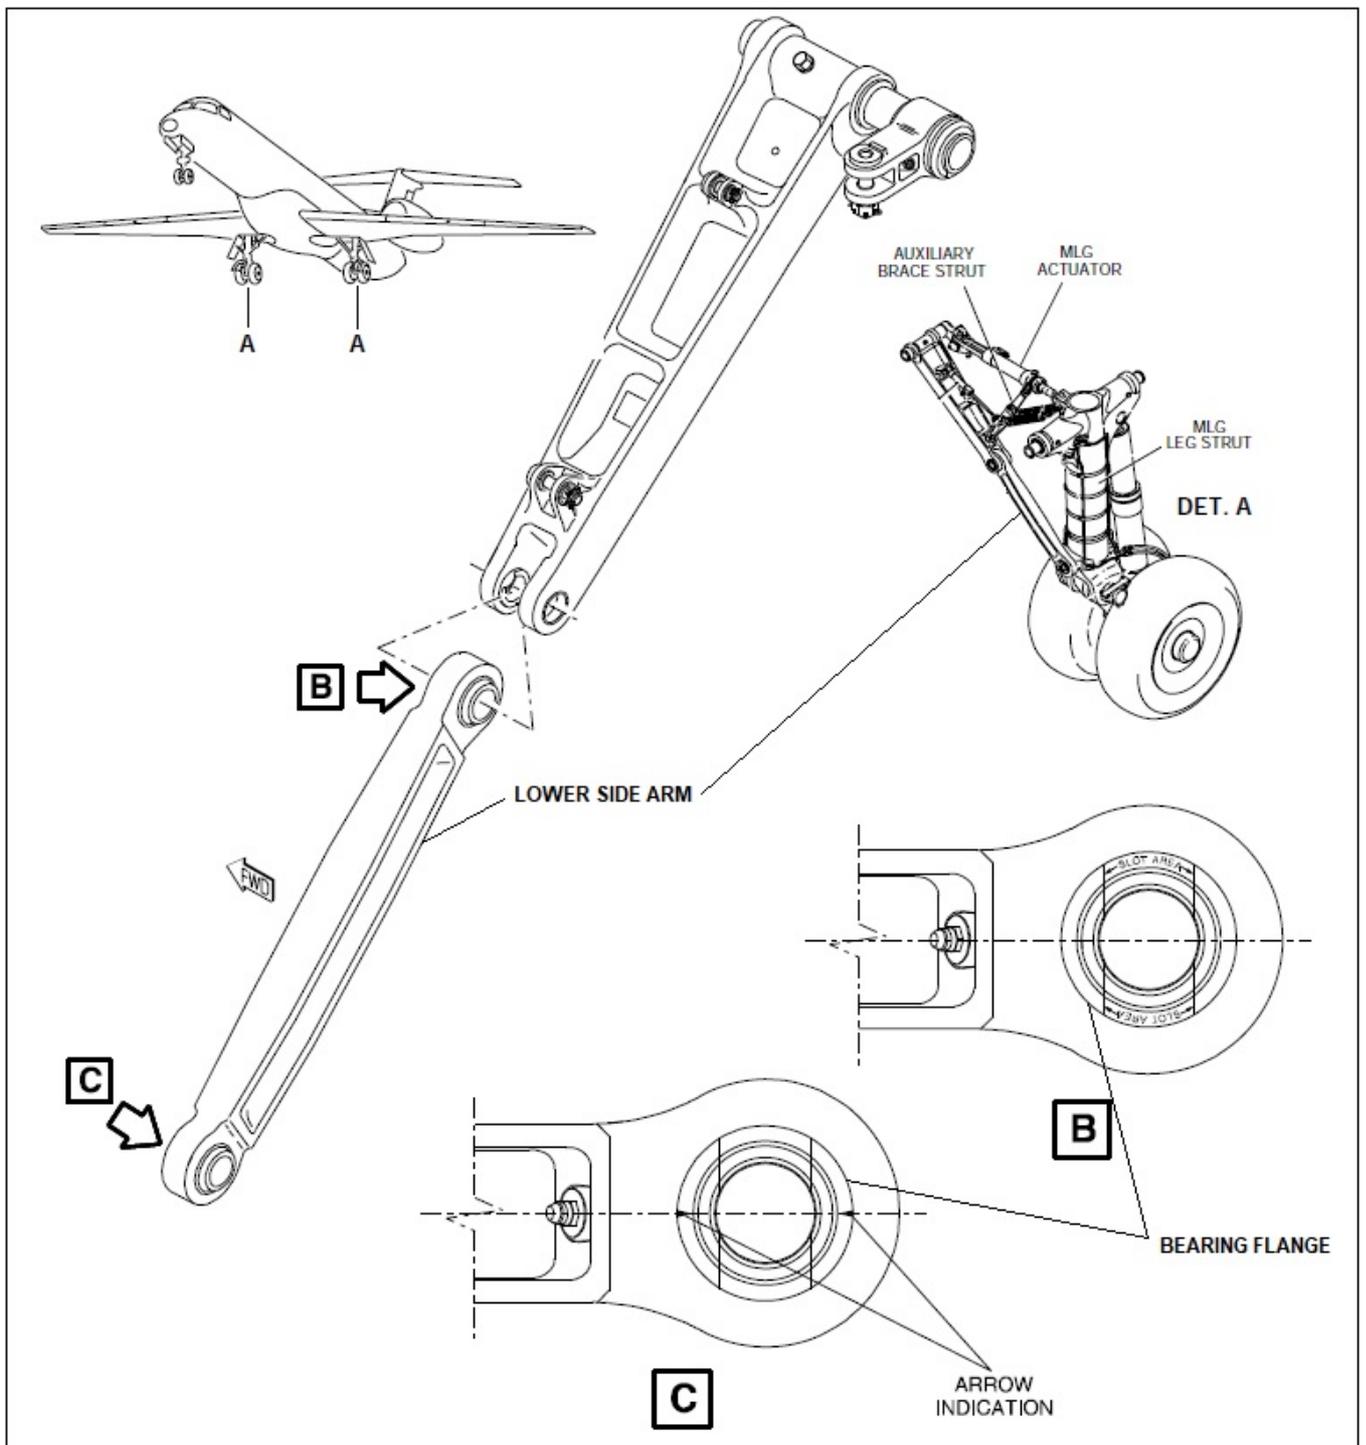
It was determined that the inverted installation of the MLG Side Arm Strut Bearing was a contributing factor to the disconnection of the Side Arm Strut from the Main Landing Gear.

Figure 2: Correct installation of the Lower Side Arm Bearings

A one-time inspection, and reinstallation of the MLG Side Arm Strut, if necessary, as to the inverted installation of the Bearings (see Figure 2).

2. Verify that the flanges of the 2 MLG Side Arm Bearings are both facing the flight direction (see Details B and C in Figure 2 below);

- i. If, during the inspection required by item (a)(2) above, it is found that either of the Bearing's flanges is installed inverted (flange facing opposite to the flight direction), before the next flight (see NOTE 2), remove the Lower side Arm and re-install the affected Bearing in the correct position (flange facing the flight direction). To comply with this paragraph, refer to procedure 32-10-03/400 (MAIN-LANDING-GEAR MAIN BRACE STRUT - REMOVAL/INSTALLATION) of the AMM applicable to the aircraft, and to the CMM (Component Maintenance Manual), procedure T.P. 145/1190\_32-10-03, as necessary.
3. Verify that there is no migration of both Bearings of the MLG Side Arm (see Details B and C in Figure 2) (both Flanges shall be flushed with the MLG Lower Side Arm face);
