**Directive de Navigabilité de l'EASA de référence 2021-0107**

**Avions PIPER PA-28 et PIPER PA-32**

Ailes - Semelle de longeron inférieur de l'aile principale - Inspection

**AD No.: 2021-0107**

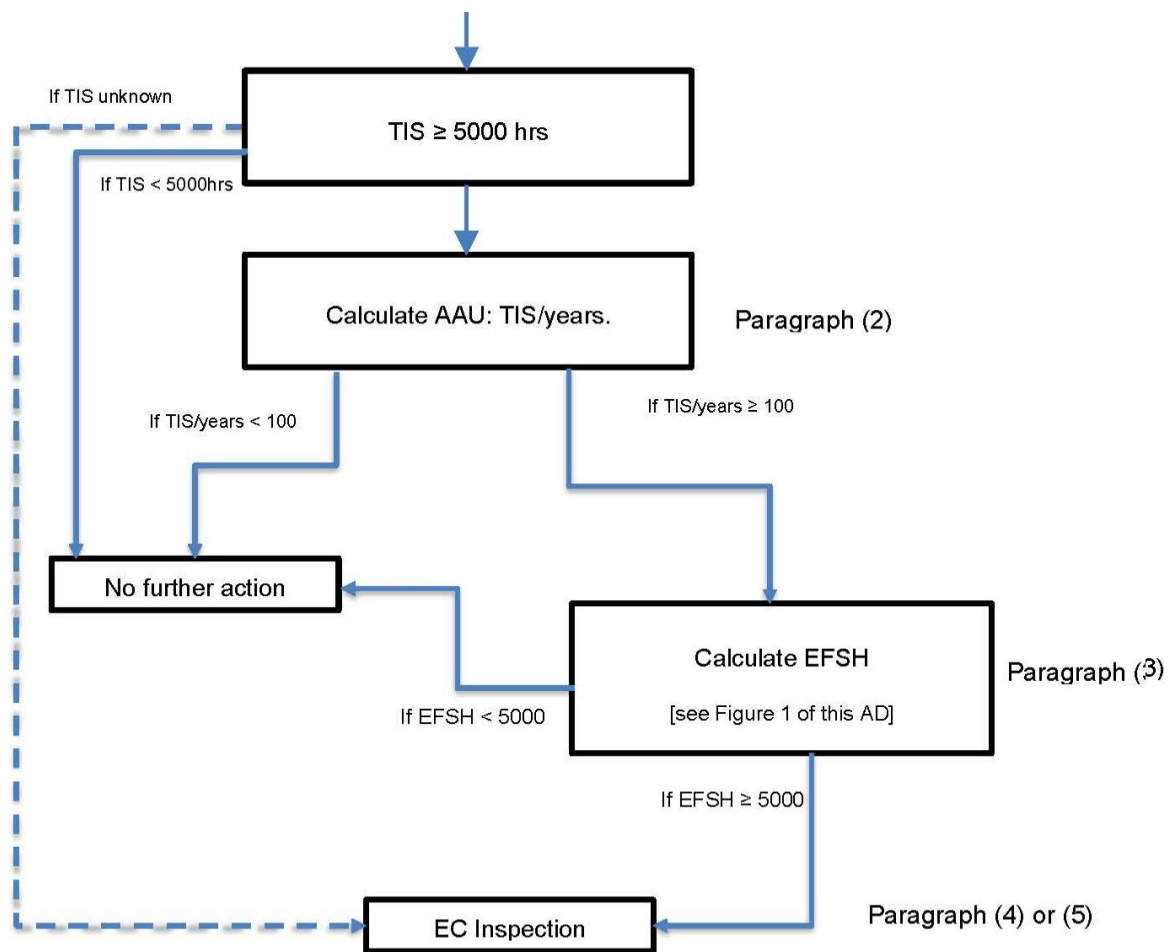
## Appendix 2 – Flowchart / Examples of Calculation

For a spar with 8 calendar years and 700 hours TIS (TIS=700), the results would be:

1. Paragraph (2):  $TIS/years = 700/8 = 87,5 < 100 \rightarrow$  no action required.

For a spar with 8 calendar years and 3 000 hours TIS Hours (TIS=3 000), the results would be:

1. Paragraph (2):  $TIS/years = 3\,000/8 = 375 > 100 \rightarrow$  go to paragraph (3);
2. Paragraph (3):  $EFSH = (3\,000 - 100 \times 8) + (100 \times 8)/15 = 2\,253 < 5\,000 \rightarrow$  no further action

For a spar with 8 calendar years and 6 000 hours TIS (TIS = 6 000), the results would be:

1. Paragraph (2):  $TIS/years = 6\,000/8 = 750 > 100 \rightarrow$  go to paragraph (3);
2. Paragraph (3):  $EFSH = (6\,000 - 100 \times 8) + (100 \times 8)/15 = 5\,253 \rightarrow$  go to paragraph (4).

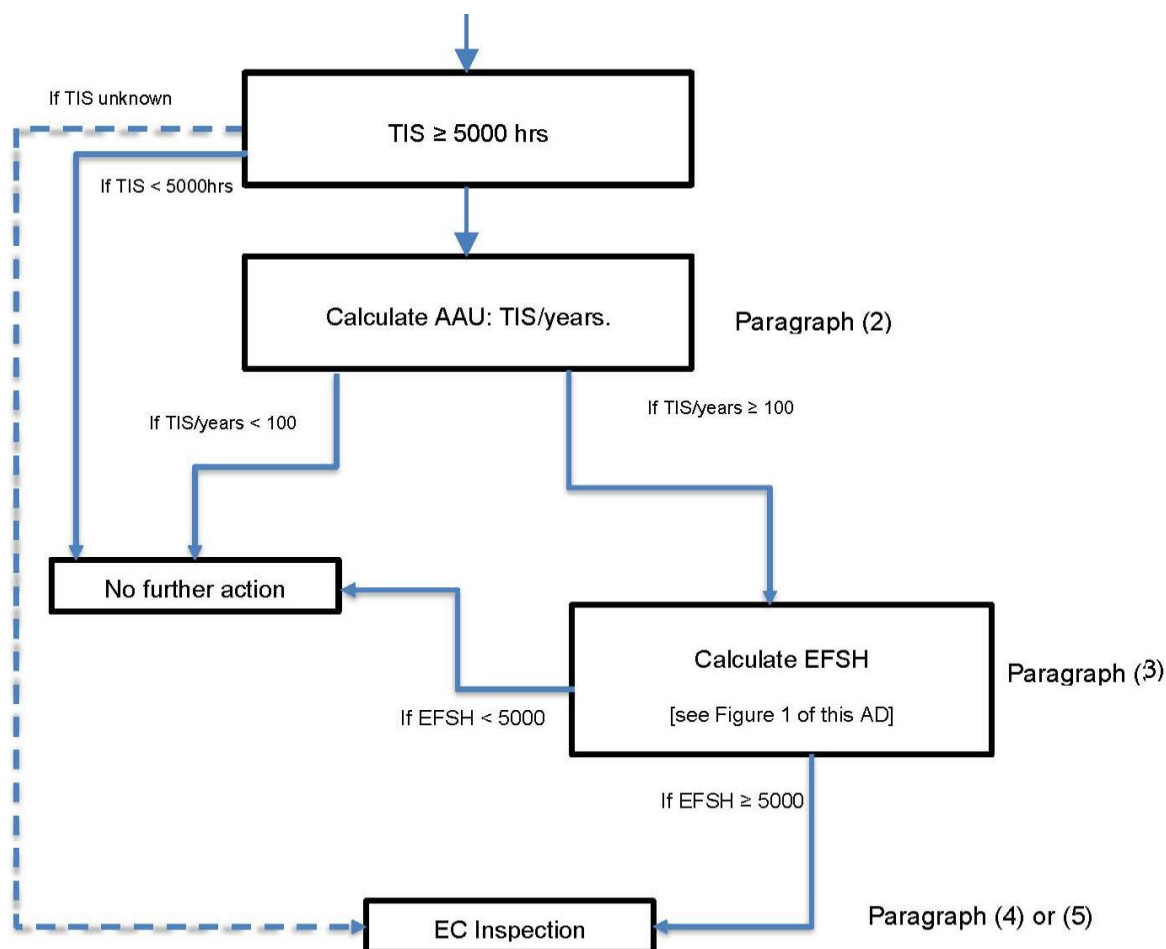
## Annexe 2 - Organigramme / Exemples de calcul

For a spar with 8 calendar years and 700 hours TIS (TIS=700), the results would be:

1. Paragraph (2):  $TIS/years = 700/8 = 87,5 < 100 \rightarrow$  no action required.

For a spar with 8 calendar years and 3 000 hours TIS Hours (TIS=3 000), the results would be:

1. Paragraph (2):  $TIS/years = 3\,000/8 = 375 > 100 \rightarrow$  go to paragraph (3);
2. Paragraph (3):  $EFSH = (3\,000 - 100 \times 8) + (100 \times 8)/15 = 2\,253 < 5\,000 \rightarrow$  no further action

For a spar with 8 calendar years and 6 000 hours TIS (TIS = 6 000), the results would be:

1. Paragraph (2):  $TIS/years = 6\,000/8 = 750 > 100 \rightarrow$  go to paragraph (3);
2. Paragraph (3):  $EFSH = (6\,000 - 100 \times 8) + (100 \times 8)/15 = 5\,253 \rightarrow$  go to paragraph (4).
