Airworthiness Directive

AD No.: 2022-0168

EC135, EC635 and MBB-BK117 helicopters
EC 175 B and H160-B helicopters

ATA 42 – Integrated Modular Avionics – Ethernet Network – Inspection

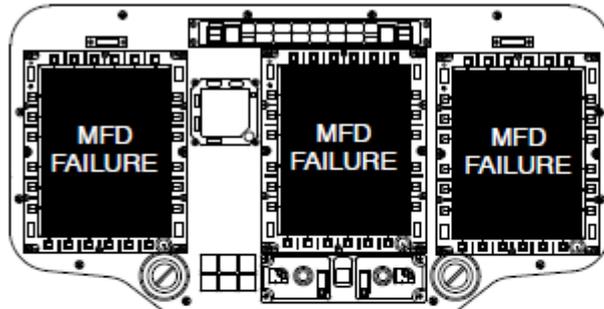
- MFDs:

- MFD FAILURE displayed on all MFDs
- If autopilot upper modes were coupled, they may decouple after 10 seconds (indicated by an „autopilot decouple“ voice message).
