[Docket No. FAA-2023-1814; Project Identifier AD-2023-00773-T; Amendment 39-22541; AD 2023-17-14]

Airworthiness Directives; The Boeing Company Airplanes

The FAA is superseding Airworthiness Directive (AD) 2022-18-11, which applied to all The Boeing Company Model 777 airplanes. AD 2022-18-11 required repetitive inspections for cracking of the left- and right-side ring chords, repair angles, front spar lower chords, and front spar webs (depending on configuration) common to a certain underwing longeron; modification of the front spar lower chord for some airplanes; repetitive post-modification inspections; and applicable on-condition actions. This AD was prompted by a report of a crack found in a front spar lower chord, and the determination that errors in the service information mandated by AD 2022-18-11 introduced a new unsafe condition related to the application of certain fastener cap seals. This AD retains the actions required by AD 2022-18-11, and requires a maintenance records review of previously modified airplanes for the procedures used during that modification, and applicable corrective actions. The FAA is issuing this AD to address the unsafe condition on these products

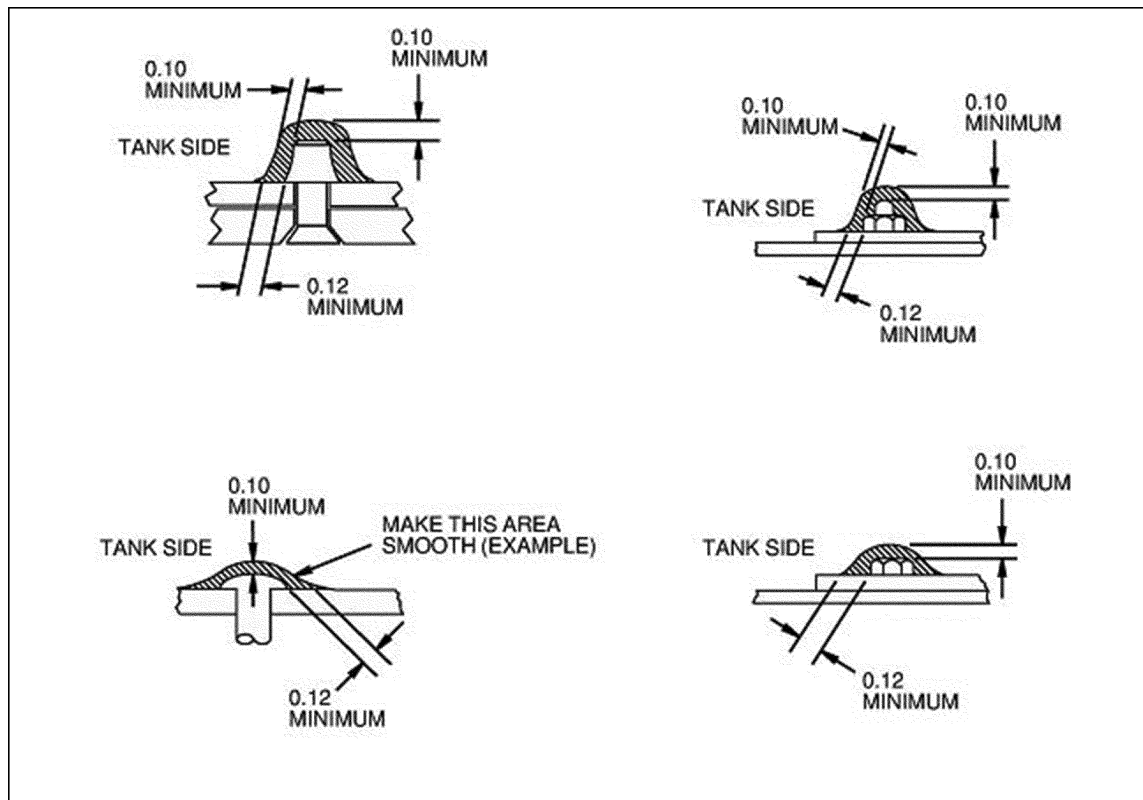
Figure 1 to paragraph (h)(4) – Cap seal minimum thickness (all dimensions in inches)

required by the requirements bulletin. A cap seal of insufficient thickness may fail to contain a spark resulting from a lightning strike, similarly compromising the fault tolerance of the fuel tank lightning protection. This AD specifies the minimum thickness and sealant type for an applied cap seal, and requires replacement of any seal that was previously applied using a procedure that specifies an inadequate thickness.

(4) During application of any cap seal to a fastener, fastener head, and fastener threads and collars, as required by this AD, the cap seal must be applied with a thickness equal to or greater than the dimensions specified in figure 1 to paragraph (h)(4) of this AD.

(ii) All cap seals were applied using procedures with thickness dimensions greater than or equal to those given in figure 1 to paragraph (h)(4) of this AD.

(2) If any cap seal was applied using procedures with thickness dimensions less than those given in figure 1 to paragraph (h)(4) of this AD, or if the maintenance records do not definitively specify the procedures used: At the applicable time specified in paragraph (i)(2)(i) or (ii) of this AD, replace the cap seal in accordance with the Accomplishment Instructions of Boeing Alert Requirements Bulletin 777-57A0122 RB, dated October 8, 2021, using a cap sealing procedure with thickness greater than or equal to the dimensions given in figure 1 to paragraph (h)(4) of this AD.

(3) For any cap seal that was not applied, or for any cap seal that was removed for inspections and not replaced, or if the maintenance records do not definitively specify the procedures used: At the applicable time specified in paragraph (i)(3)(i) or (ii) of this AD, apply a cap seal of BMS 5-45 sealant using an accepted method with thickness greater than or equal to the dimensions given in figure 1 to paragraph (h)(4) of this AD.
