### Directive de Navigabilité de l'EASA de référence 2023-0193

THEO SCHROEDER FIRE BALLOONS GmbH

FB6 Double Burner Assembly

## ATA 28 – Fuel – Hot Air Balloon Burner Assembly and Hanger – Inspection / Modification

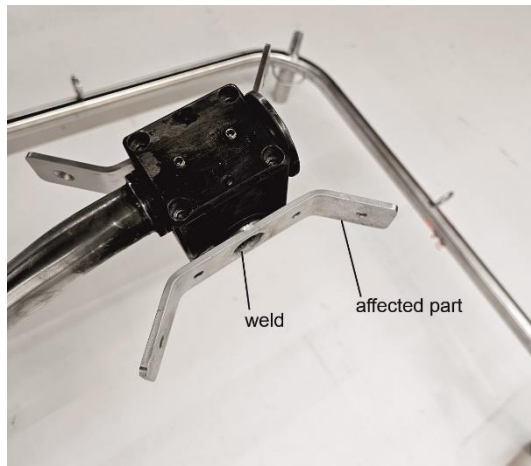
Figure 1 – Affected Part

**Affected part:** Connector of FB6 double burner hanger, except a serviceable part. See Appendix 1 to this AD.

An occurrence was reported of a burner type FB6 S/N 2.1239-1 where the connector between the burners was found detached during transportation, leaving one burner unit detached from the load frame. Investigation revealed that the welding process may have been improperly done, due to an insufficiently detailed description of that process in production. The suspected direct cause of failure is fatigue cracking of the weld, mainly due to improper handling during transportation.

This condition, if not detected and corrected, could lead to in-flight burner detachment, possibly resulting in injury to balloon occupants. It could also lead to an uncontrolled (cold) descent and hard landing, possibly resulting in injury to balloon occupants and/or persons on the ground.

- (1) Within 12 months or 100 flight hours (FH), whichever occurs first after the effective date of this AD, accomplish an inspection of the weld of each affected part, installed on a balloon, in accordance with the instructions of the TN.

- (2) If, during the inspection as required by paragraph (1) of this AD, any crack is detected or evidence of a weld with insufficient filler material is found, before next flight, replace the affected part with a serviceable part, in accordance with the instructions of the TN.

- (3) If, during the inspection as required by paragraph (1) of this AD, sufficient filler material, as defined in the TN, is found on an affected part, before next flight, mark that part in accordance with the instructions of the TN.

- (4) From the effective date of this AD, do not install an affected part, or a burner assembly having an affected part installed, on any balloon.

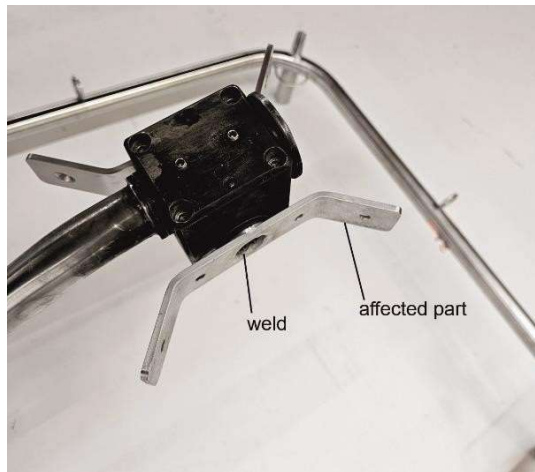
Figure 1 –  
Pièce  
affectée

**Pièce affectée** : Connecteur de la suspension du double brûleur FB6, à l'exception d'une pièce en bon état. Voir l'annexe 1 de la présente CN.

Un brûleur de type FB6 S/N 2.1239-1 a fait l'objet d'un rapport dans lequel le connecteur entre les brûleurs s'est détaché pendant le transport, laissant un brûleur détaché du cadre de charge. L'enquête a révélé que le processus de soudage pourrait avoir été mal effectué, en raison d'une description insuffisamment détaillée de ce processus dans la production. La cause directe présumée de la défaillance est la fissuration par fatigue de la soudure, principalement due à une mauvaise manipulation pendant le transport.

Cette situation, si elle n'est pas détectée et corrigée, pourrait entraîner le détachement du brûleur en vol, ce qui pourrait blesser les occupants du ballon. Elle pourrait également entraîner une descente incontrôlée (à froid) et un atterrissage brutal, avec des risques de blessures pour les occupants du ballon et/ou les personnes au sol.

- (1) Dans les 12 mois ou 100 heures de vol (FH), selon ce qui se produit en premier après la date d'entrée en vigueur de la présente CN, effectuer une inspection de la soudure de chaque pièce concernée, installée sur un ballon, conformément aux instructions de la TN.

- (2) Si, au cours de l'inspection prévue au paragraphe 1 de la présente CN, une fissure est détectée ou des signes d'une soudure avec un matériau d'apport insuffisant sont découverts, avant le vol suivant, remplacer la pièce affectée par une pièce en état, conformément aux instructions de la TN.

- (3) Si, au cours de l'inspection requise par le paragraphe (1) de la présente CN, une quantité suffisante de matériau d'apport, telle que définie dans la TN, est trouvée sur une pièce affectée, avant le prochain vol, marquer cette pièce conformément aux instructions de la TN.

- (4) A partir de la date d'entrée en vigueur de cette CN, ne pas installer une pièce affectée, ou un brûleur sur lequel une pièce affectée est installée, sur un ballon.
