Civil Aviation Authority
**EMERGENCY
AIRWORTHINESS
DIRECTIVE**

Number: G-2024-0001-E

Lindstrand Technologies Limited

ATA - Hot Air Balloons - Envelopes with Polyester Filled Aramid (Kevlar) Load Tapes – Removal from Service

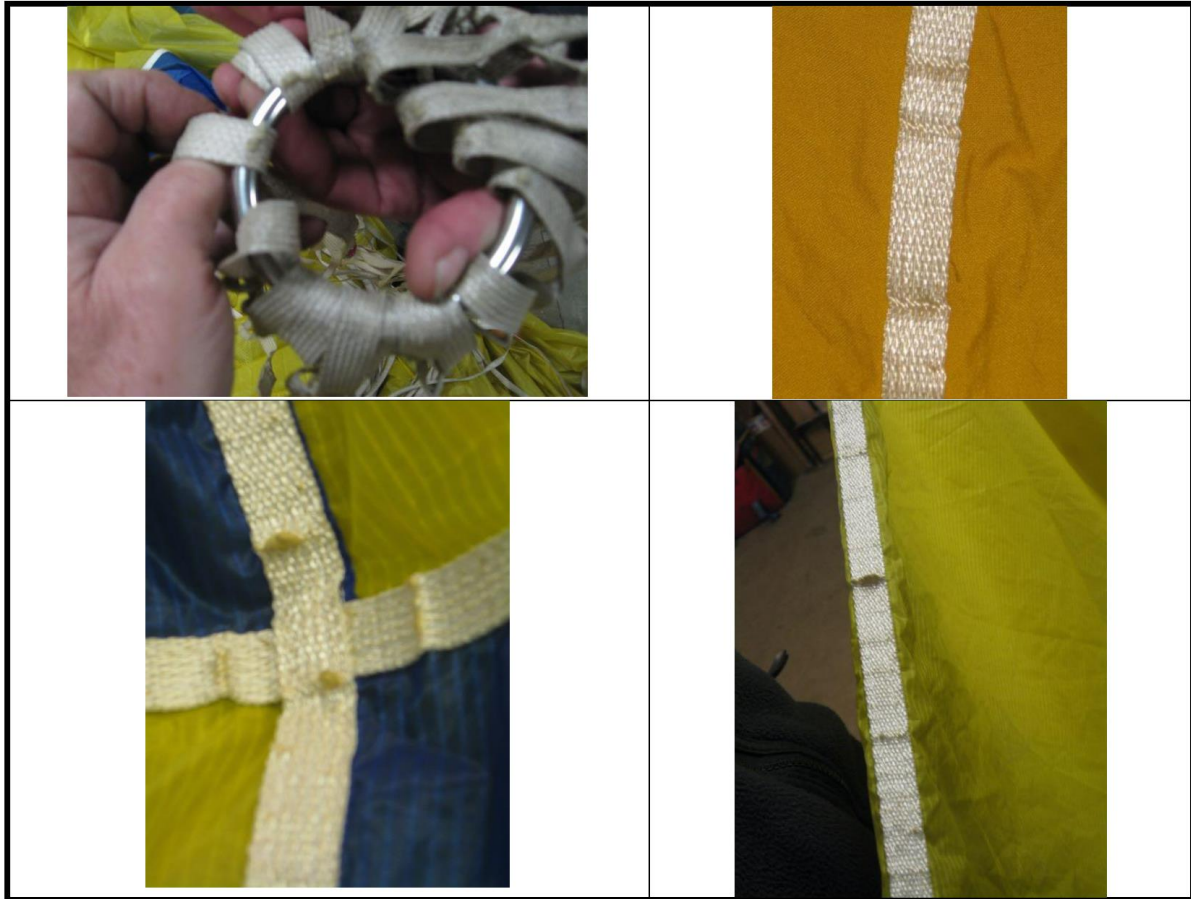
Figure 1 : exemple de dommage du ruban de charge

Au cours d'une inspection de routine 100 heures/annuelle d'une enveloppe, il a été découvert que les rubans de charge en Polyester Aramide s'étaient considérablement dégradés (voir figure 1).

Les dommages ont permis à l'âme en Kevlar (colorée en jaune) d'être exposée, ce qui dégrade la résistance de la bande en raison de l'exposition aux ultraviolets. Les rubans horizontaux et verticaux sont affectés et ceux horizontaux présentent des déformations importantes.

De plus, à l'endroit où le ruban se boucle autour de l'anneau de la couronne, le polyester a complètement cédé, et le Kevlar est totalement exposé. À d'autres endroits, les rubans de charge se sont étirés et effilochés.

L'enveloppe qui a été inspectée n'a effectué que 100 heures de vol.

Bien que le manuel d'entretien indique qu'aucun dommage aux rubans de chargement n'est acceptable, une situation dangereuse pourrait exister car la vitesse de dégradation est inconnue et la résistance résiduelle du ruban après exposition aux UV ne peut être déterminée.

1. Avant tout autre vol à compter de la date d'entrée en vigueur de la présente CN, procéder à une inspection visuelle afin de déterminer la date de fabrication (à partir de la plaque signalétique de l'enveloppe) et si l'enveloppe est équipée de de rubans de charge en polyester aramide (Kevlar).

2. Si la date de fabrication est postérieure à mars 2017 **et** que l'enveloppe s'est avérée, lors de l'inspection, être équipée de rubans de charge optionnels en polyester aramide (Kevlar), l'enveloppe doit être considérée comme un **numéro de série affecté** aux fins de cette CN.
3. Si l'enveloppe porte un **numéro de série affecté**, procédez à une inspection visuelle complète des bandes de chargement.
4. Si des dommages sont visibles, aucun autre vol n'est autorisé tant que les dommages n'ont pas été réparés.
5. **Si aucun dommage n'est visible, modifier le programme d'entretien de l'aéronef pour inclure une inspection visuelle complète des rubans de charge verticaux et horizontaux avant chaque vol.**

Note : cette inspection visuelle peut être effectuée par le pilote/propriétaire. En cas de doute, l'enveloppe doit être inspectée par un technicien dûment qualifié.
