## Airworthiness Directive

**AD No.:** 2024-0096R1

ATR 42 and ATR 72 aeroplanes

## ATA 27 – Flight Controls – Rudder Travel Limiting Unit – Inspection

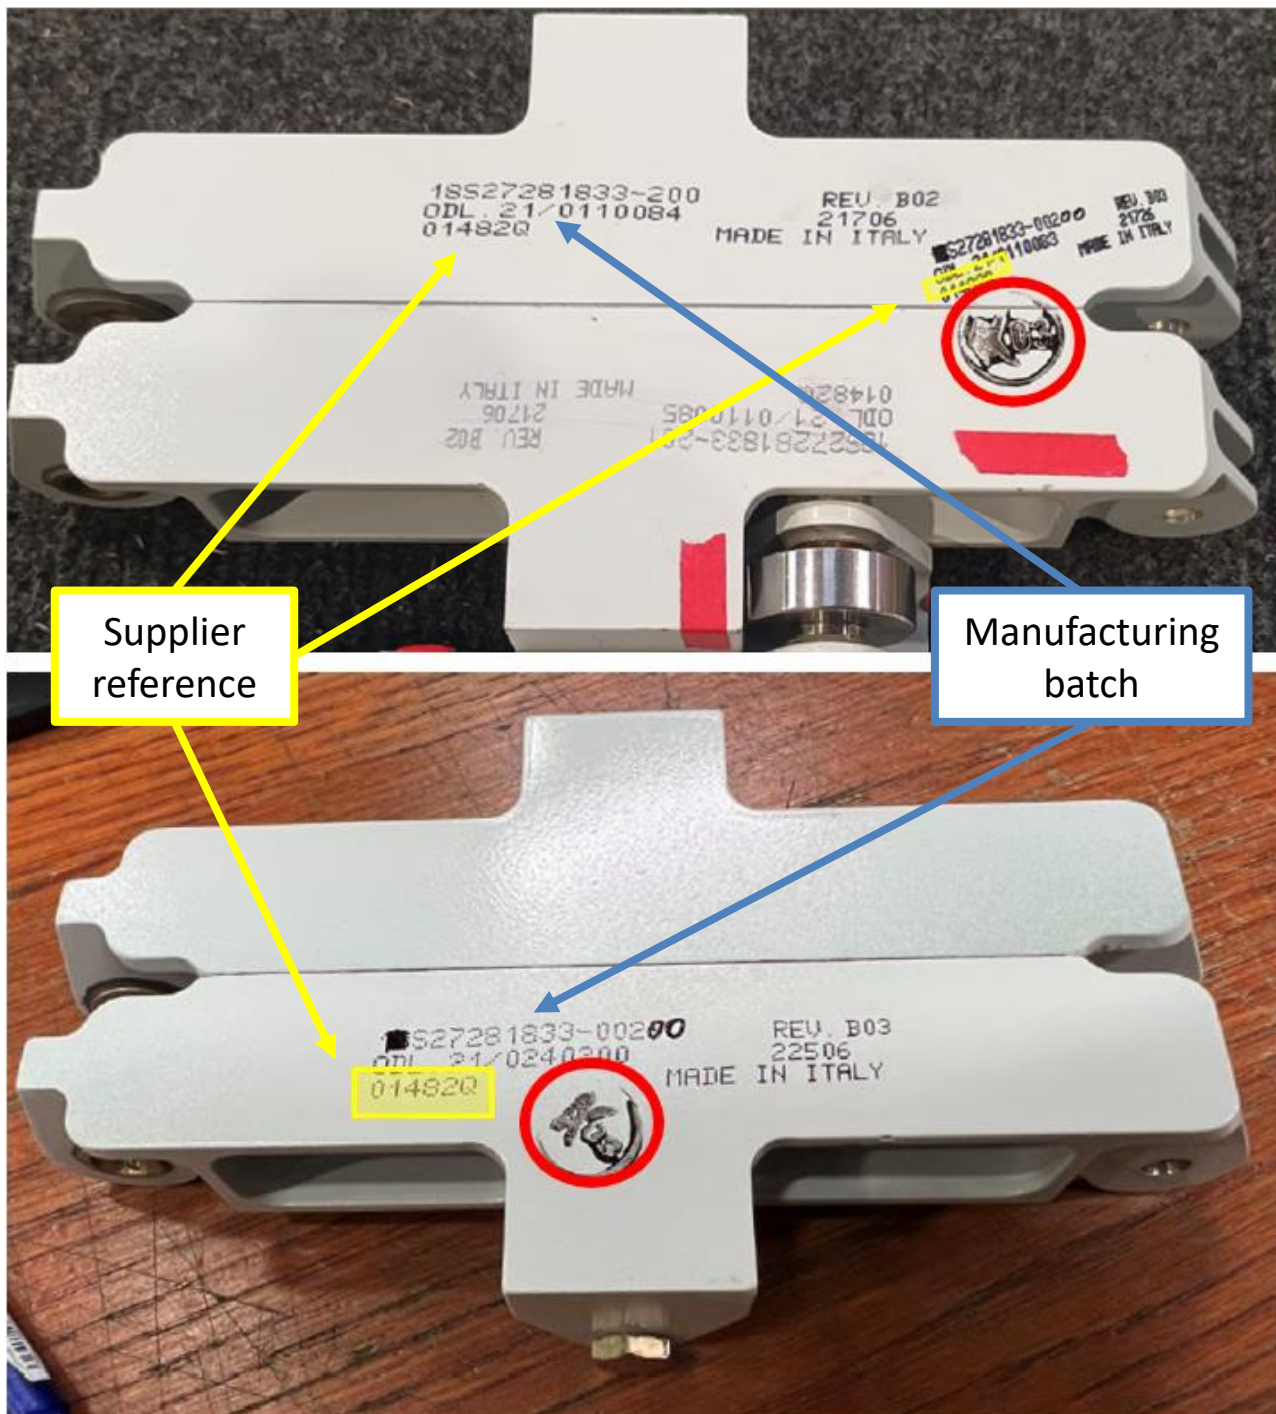
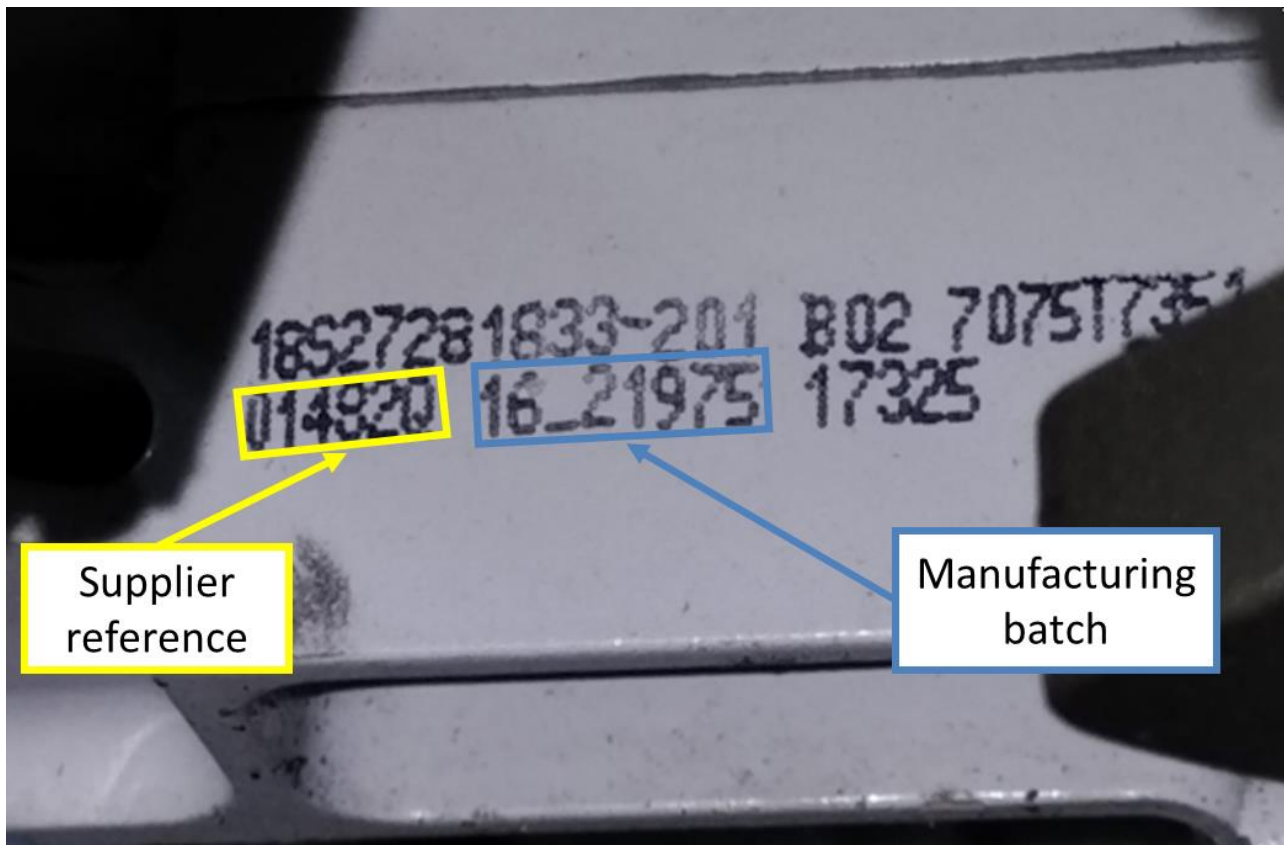
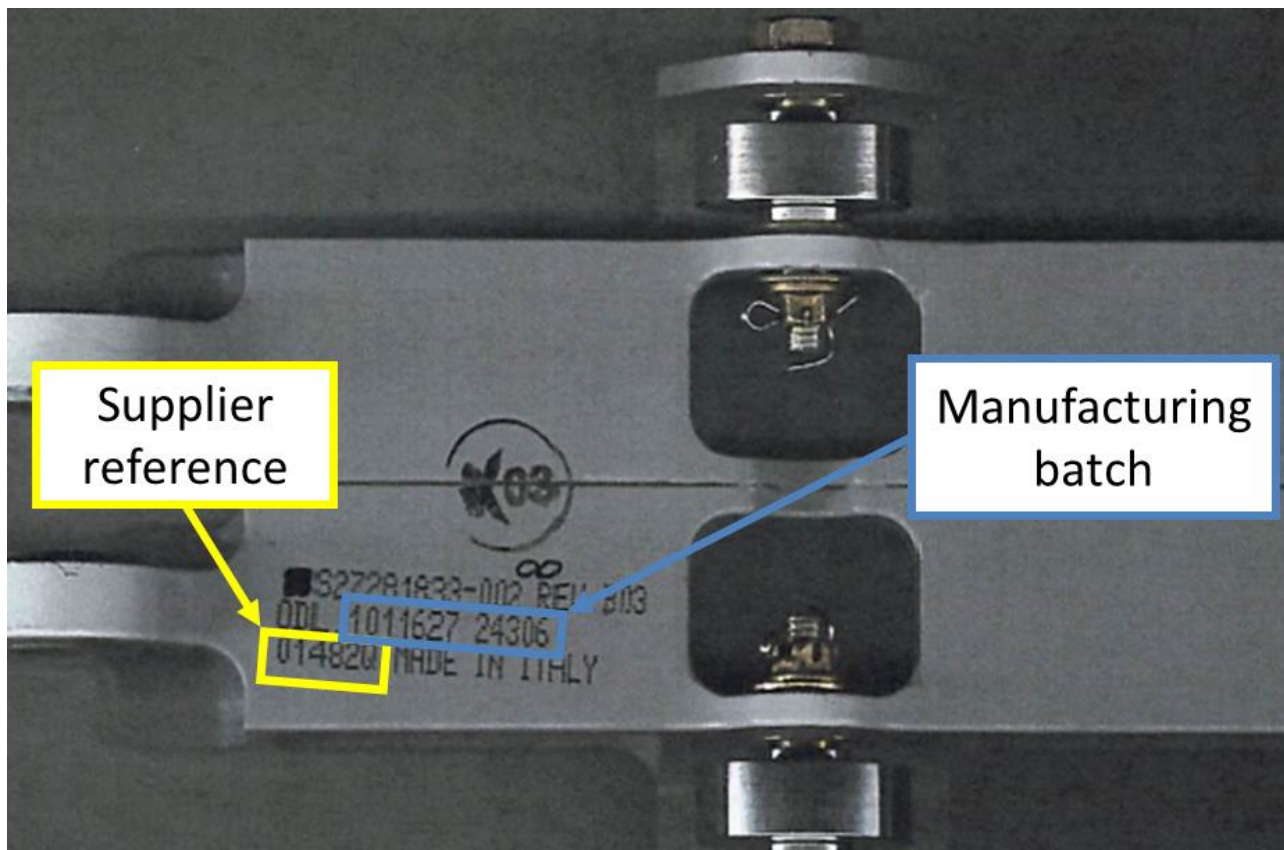
Appendix 1 - TLU Supplier Code and Manufacturing Batch Identification

Note 1: The supplier code and the manufacturing batch of the TLU lever can be identified directly on the part; an example is provided in Appendix 1 of this AD.
