**OBJET : Avis d'émission de l'AD urgente de l'EASA de référence EAD 2024-0179-E**  
(*EASA EAD 2024-0179-E issuing notice*)

**Groupe motopropulseur - Boulons de montage du moteur - Remplacement**

**AD No.:** 2024-0179-E

## ATA 71 – Power Plant – Engine Mount Bolts – Replacement

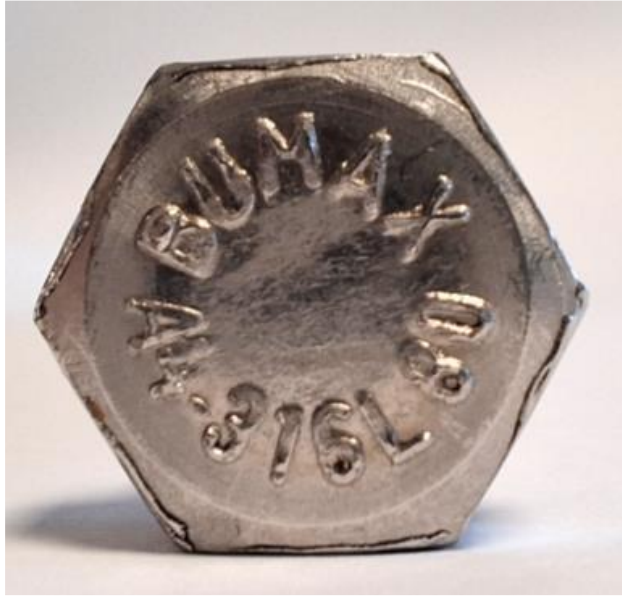
Annex 1 - Affected Part Identification

**Affected part:** Engine mount bolt having Part Number PRD-00100696 and marked “BUMAX” on its head, which:

- has been installed in production on MSN 002, 011, and 013 to 028 inclusive; or
- has batch number 2011070000000029; or
- for which the batch number is not known.

See picture in the Annex 1 to this AD.

During engine installation on a new aeroplane in production, incorrect bolts were identified.

This condition, if not detected and corrected, could reduce the structural integrity of the engine attachments, potentially leading to damage to other aeroplane systems or detachment of an engine resulting in loss of control of the aeroplane.

For the reason described above, this AD requires replacement of all 4 engine mount bolts for Group 1 aeroplanes with serviceable parts, and prohibits (re)installation of affected part.

(1) For Group 1 aeroplanes: Before next flight after the effective date of this AD, replace all 4 engine mount bolts, as identified in Figure 1 of the ASB, with serviceable parts in accordance with the instructions of the ASB.

(3) For Group 1 and Group 2 aeroplanes: From the effective date of this AD, do not install an affected part on any aeroplane.

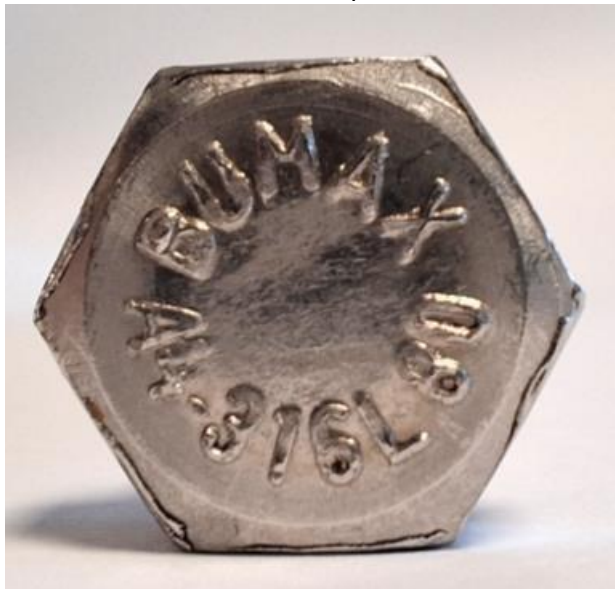
Annexe 1 - Identification des pièces concernées

**Pièce concernée** : Boulon de montage du moteur portant le numéro de pièce PRD-00100696 et marqué « BUMAX » sur sa tête, qui

- a été installé en production sur les MSN 002, 011 et 013 à 028 inclus ; ou
- porte le numéro de lot 2011070000000029 ; ou
- dont le numéro de lot n'est pas connu.

Voir l'image dans l'annexe 1 de cette CN.

Lors de l'installation du moteur sur un nouvel avion en production, des boulons incorrects ont été identifiés.

Cette situation, si elle n'est pas détectée et corrigée, pourrait réduire l'intégrité structurelle des fixations du moteur, ce qui pourrait endommager d'autres systèmes de l'avion ou entraîner le détachement d'un moteur et la perte de contrôle de l'avion.

Pour la raison décrite ci-dessus, cette CN exige le remplacement des 4 boulons de support moteur pour les avions du groupe 1 par des pièces en bon état, et interdit la (ré)installation de la pièce affectée.

(1) Pour les avions du groupe 1 : Avant le prochain vol après la date d'entrée en vigueur de la présente CN, remplacer les 4 boulons du support moteur, identifiés à la figure 1 de l'ASB, par des pièces bon état conformément aux instructions de l'ASB.

(3) Pour les avions des groupes 1 et 2 : À partir de la date d'entrée en vigueur de la présente CN, ne pas installer de pièce affectée sur un avion.
