## Airworthiness Directive

**AD No.:** 2024-0221

**Issued:** 22 November 2024

## ATA 78 – Exhaust – Engine / Turbocharger Exhaust System / Components – Inspection

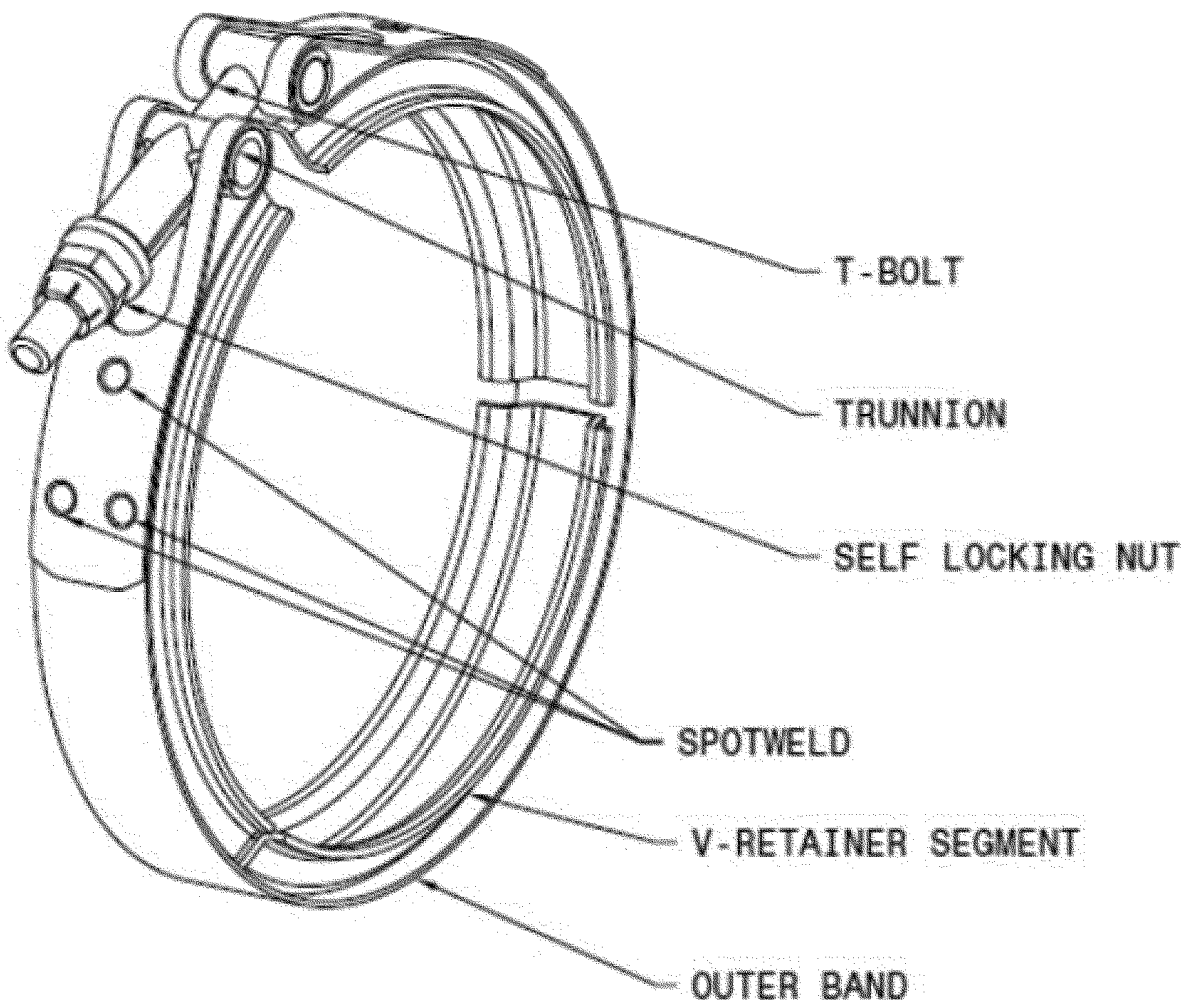
Figure 1 – Spot-Welded, Multi-Segment Exhaust Tailpipe V-Band Coupling

Failures have been reported of spot-welded, multi-segment v-band couplings, installed at the tailpipe to the turbocharger exhaust housing flange. Over the years, this has resulted in a significant number of incidents and accidents (fatal and non-fatal) on both aeroplanes and helicopters. To address this safety subject, the FAA has issued multiple ADs (listed in Appendix 2 of this AD) for specific type designs, as well as several Special Airworthiness Information Bulletins (SAIB).

Since those actions, the FAA constituted a working group to study v-band coupling failures associated with turbocharged reciprocating engine-powered aircraft depending on each specific coupling type (spot-welded, riveted, or single piece). The working group's final report determined that riveted couplings are not affected by a safety concern, and concluded that the common denominator in the incidents and accidents reviewed is the spot-welded, multi-segment exhaust tailpipe v-band coupling (see Figure 1 of this AD). These couplings come in either two or three segment varieties. The segments are the number of v-retainer segments, which are attached to the outer band via spot welds. The majority of the events studied by the working group indicated fatigue failure of affected parts as a result of stress corrosion cracking that originated at or near a spot weld.

This condition, if not detected and corrected, could lead to failure of the affected part, leading to detachment of the exhaust tailpipe from the turbocharger and allowing high-temperature exhaust gases to enter the engine compartment, possibly resulting in smoke in the cockpit, in-flight fire, and loss of control of the aircraft.

- (2) For Group 1 aircraft: Within the compliance times specified in Table 1 of this AD, and, thereafter, at intervals not to exceed 500 FH, remove each affected part from service and install a serviceable part, as defined in this AD, and apply correct torque, as applicable, to the affected part nut.

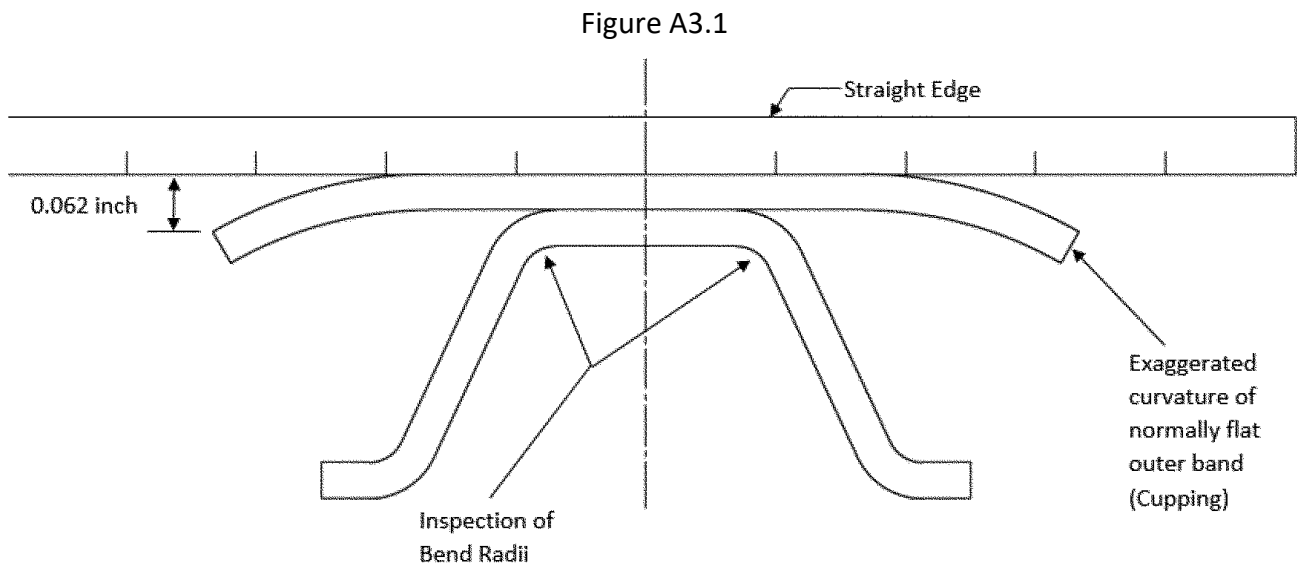
- (a.4) Visually inspect the affected part outer band for cupping, bowing, and crowning as depicted in Figure A3.1 of paragraph (b.4) of this Appendix. If there is any cupping, bowing, or crowning, before next flight, remove the affected part and, instead of the inspections in paragraphs (a.5) through (a.7) of this Appendix, do the inspections in paragraph (b) of this Appendix.

- (b.6) Visually inspect the bend radii of the v-retainer coupling segments, throughout the length of the segment, as depicted in Figure A3.1 of paragraph (b.4) of this Appendix, for cracks. If there are any cracks, before next flight, remove the affected part from service and install a serviceable part, as defined in this AD.
- (b.7) Visually inspect the outer band opposite the t-bolt for damage (distortion, creases, bulging, or cracks) caused by excessive spreading of the coupling during installation or removal. If there is any damage, before next flight, remove the affected part from service and install a serviceable part, as defined in this AD.
- (b.8) If any affected part passes all inspections specified in paragraphs (b.2) through (b.7) of this Appendix, it may be re-installed.

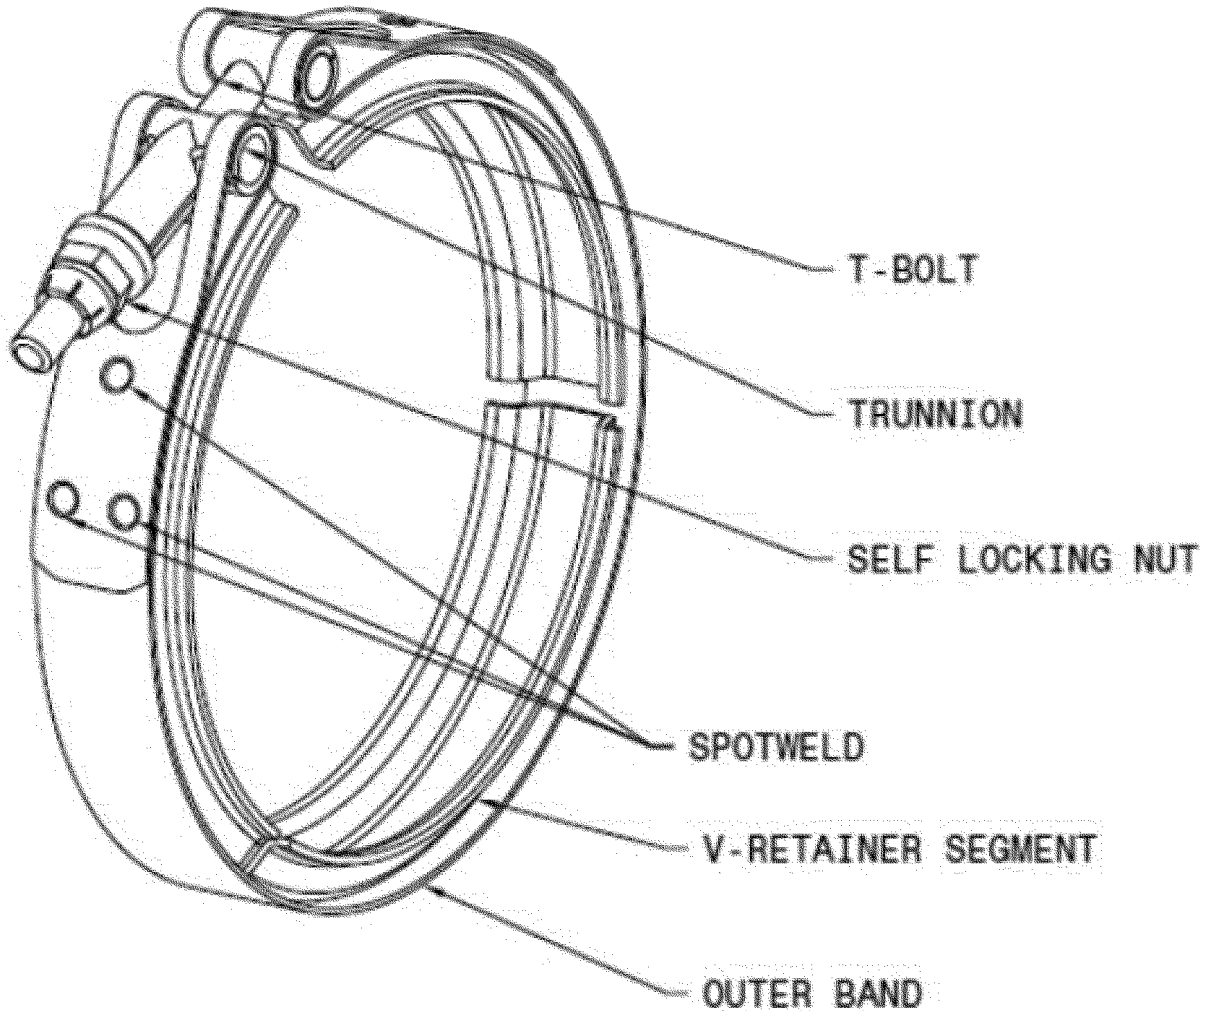
Figure 1 - Raccord en V multi-segments soudé par points pour tuyau d'échappement

Des défaillances ont été signalées sur des raccords à gorges en V multi-segments soudés par points, installés sur la bride de l'échappement du turbocompresseur. Au fil des ans, cette situation a entraîné un nombre important d'incidents et d'accidents (mortels ou non) sur des avions et des hélicoptères. Pour traiter ce problème de sécurité, la FAA a publié de nombreuses CN (énumérées à l'Annexe 2 de la présente CN) pour des types de conception spécifiques, ainsi que plusieurs bulletins spéciaux d'information de navigabilité (SAIB).

Depuis ces mesures, la FAA a constitué un groupe de travail chargé d'étudier les défaillances des raccords à bande en V associées aux aéronefs à moteur à piston turbocompressé, en fonction de chaque type d'accouplement spécifique (soudé par points, riveté ou en une seule pièce). Le rapport final du groupe de travail a établi que les raccords rivetés ne posent pas de problème de sécurité et a conclu que le dénominateur commun des incidents et accidents examinés est le raccord en V multi-segments soudé par points du tuyau d'échappement (voir la figure 1 de la présente CN). Ces raccords existent en deux ou trois segments. Les segments correspondent au nombre de segments de retenue en V, qui sont fixés à la bande extérieure par des soudures par points. La majorité des événements étudiés par le groupe de travail ont révélé une défaillance par fatigue des pièces concernées à la suite d'une fissuration par corrosion sous contrainte qui a pris naissance au niveau ou à proximité d'une soudure par points.

Cette situation, si elle n'est pas détectée et corrigée, pourrait entraîner une défaillance de la pièce concernée, ce qui conduirait au détachement du tuyau d'échappement du turbocompresseur et permettrait aux gaz d'échappement à haute température de pénétrer dans le compartiment moteur, ce qui pourrait provoquer de la fumée dans le cockpit, un incendie en vol et une perte de contrôle de l'aéronef.

(2) Pour les aéronefs du groupe 1 : Dans les délais de conformité spécifiés dans le tableau 1 de cette CN et, par la suite, à des intervalles ne dépassant pas 500 FH, retirer chaque pièce concernée du service et installer une pièce en bon état, telle que définie dans cette CN, et appliquer le couple correct, le cas échéant, à l'écrou de la pièce concernée.

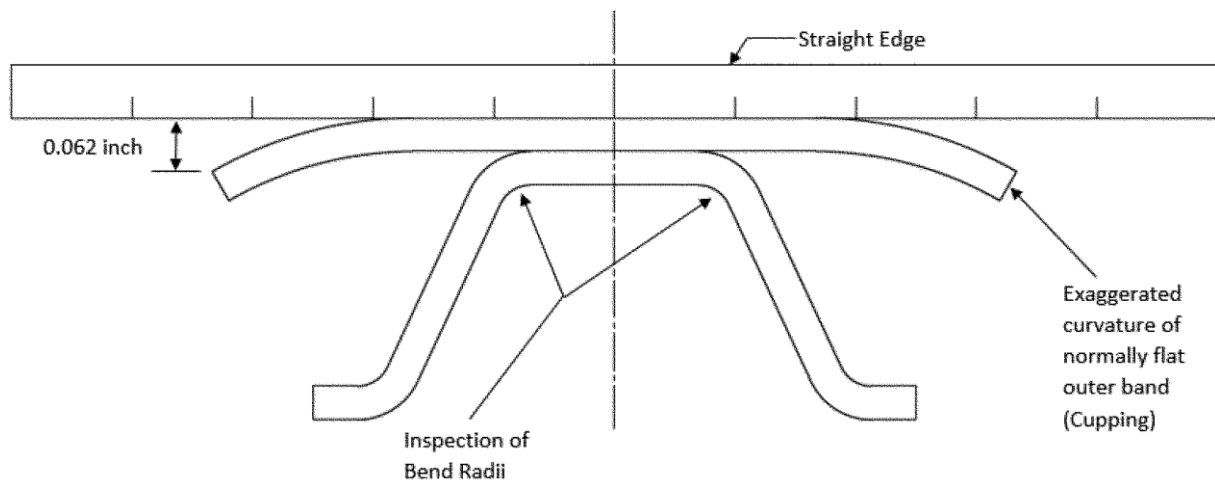
Figure A3.1

bande extérieure et la règle dépasse 0,062 pouce (1,575 mm) avant le prochain vol, retirer la pièce concernée du service et installer une pièce en bon état, telle que définie dans la présente CN.

(b.6) Inspecter visuellement les rayons de courbure des segments de couplage des gorges en V, sur toute la longueur du segment, comme illustré à la figure A3.1 du paragraphe (b.4) de la présente annexe, pour détecter les fissures. En cas de fissures, avant le prochain vol, retirer la pièce concernée du service et installer une pièce en bon, telle que définie dans la présente CN.
