AIRWORTHINESS DIRECTIVE	
Date: 12-18-2024	DA RA N° 2024- 05-01 R1	
<p>THIS AIRWORTHINESS DIRECTIVE, DEVELOPED AND ISSUED BY THE AERONAUTICAL CERTIFICATION DEPARTMENT, OFFICE OF AIRWORTHINESS, PURSUANT TO THE PROVISIONS OF ACT N.º 17285, AERONAUTICAL CODE OF THE REPUBLIC OF ARGENTINA, AND PUBLISHED IN THE OFFICIAL GAZETTE ON MAY 23, 1957 CONTAINING THE MODIFICATIONS SUBSEQUENTLY ADDED AND AIRWORTHINESS REGULATIONS, DNAR PART 39, IS APPLICABLE TO ALL AIRCRAFT OF THE SAME MAKE AND MODEL REGISTERED IN THE NATIONAL AIRCRAFT REGISTRY. AN AIRCRAFT TO WHICH A DA IS APPLICABLE MAY NOT BE OPERATED EXCEPT IN ACCORDANCE WITH THE REQUIREMENTS OF SAID DA.</p>		
APPLICABILITY		
Manufacturer LAVIA SA	Aircraft Type-Model PA25 / PA25-235 / PA25-260, INCLUDING AIRCRAFT MANUFACTURED BY PIPER, CHINCUL, LAVIASA and FAdE SA	
Revision	Revision 1	
Superseded document	This Airworthiness Directive supersedes DA RA N° 2024-05-01, Original Revision.

Reason for revision	The purpose of this revision is to incorporate instructions under APPENDIX 1 to conduct an Eddy Current NDT Inspection in specific areas of the PA-25 front wing spar, to comply with item 2b) of this Airworthiness Directive.	
Subject	Corrosion f

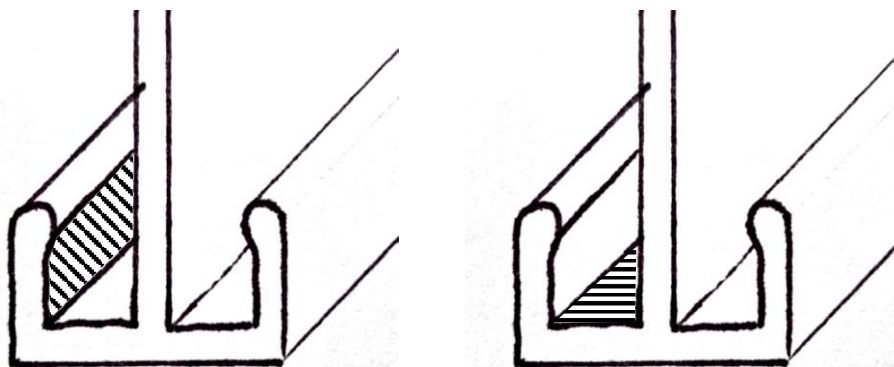
Figure 1 – Inspection areas of the PA-25 front spar

(1) The specific upper/lower spar flange areas to be inspected are shown in **Figure 1** below.

Area 1: Front spar cap flange,
leading edge fitting area

Area 2: Inside of spar cap

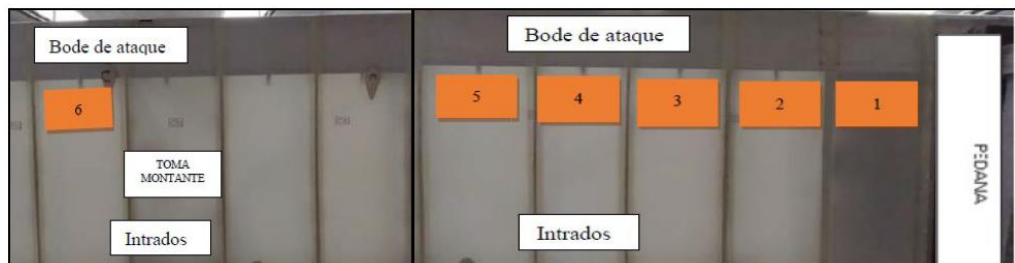
Figure 4A – Inspection access cover area according to SB25-57-11.

Access the UPPER spar cap areas through inspection access covers N.° 1 and N.° 2 and the LOWER spar cap areas through inspection access cover N.° 6 in the wing intrados, in accordance with SB25-57-11.

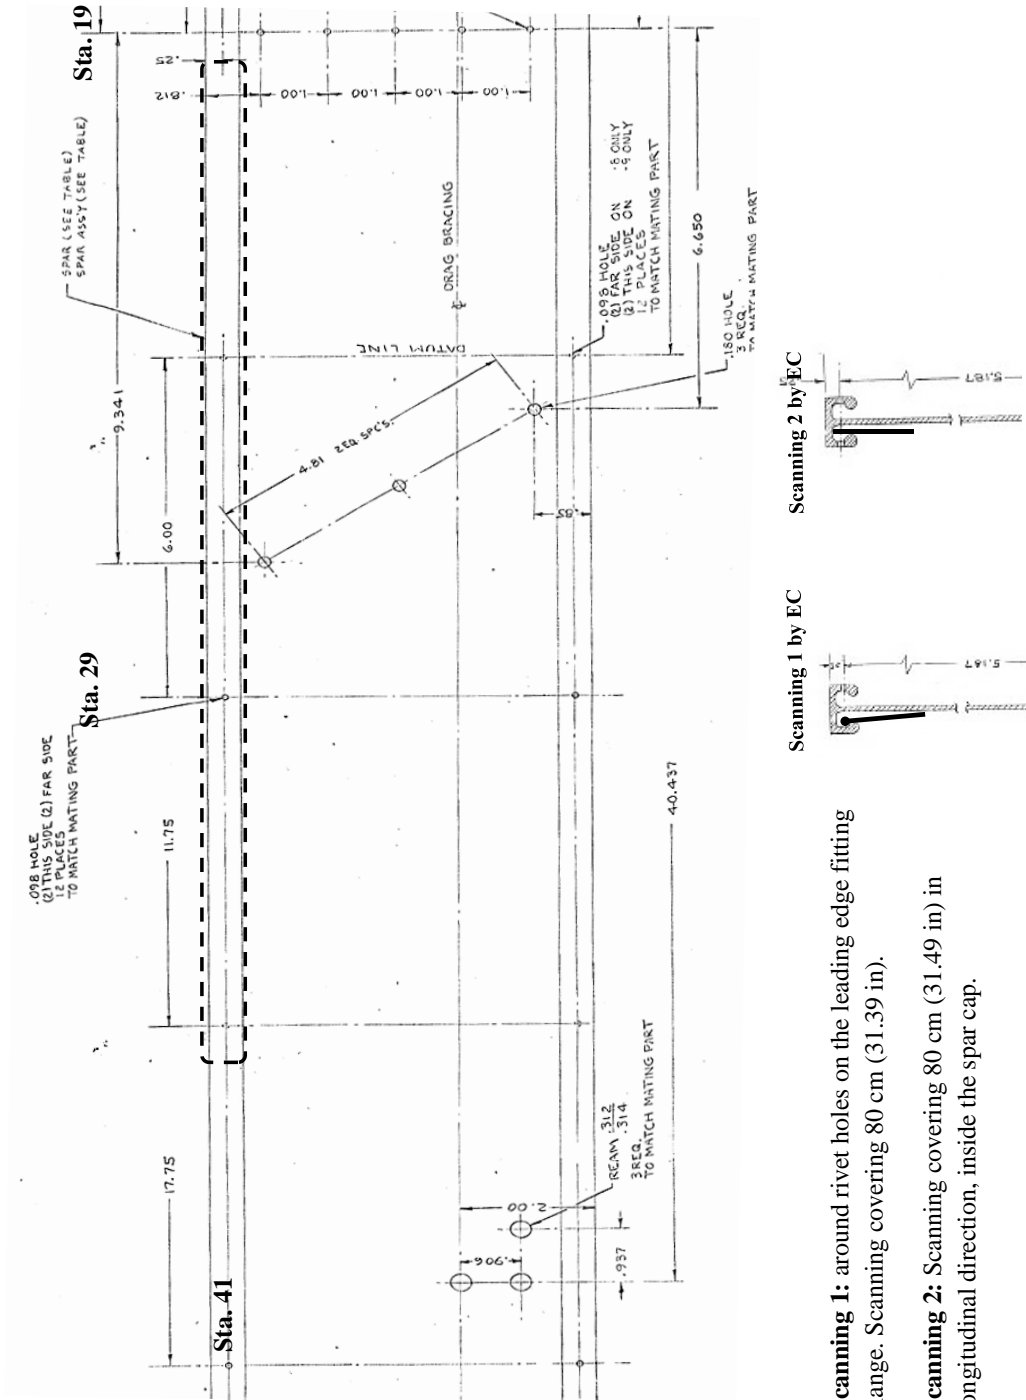
Figure 7D – Spar Caps Location

Scanning 1: around rivet holes on the leading edge fitting flange. Scanning covering 80 cm (31.39 in).

Scanning 2: Scanning covering 80 cm (31.49 in) in longitudinal direction, inside the spar cap.

ACCESS COVERS N° 1 AND N° 2 – UPPER SPAR CAP

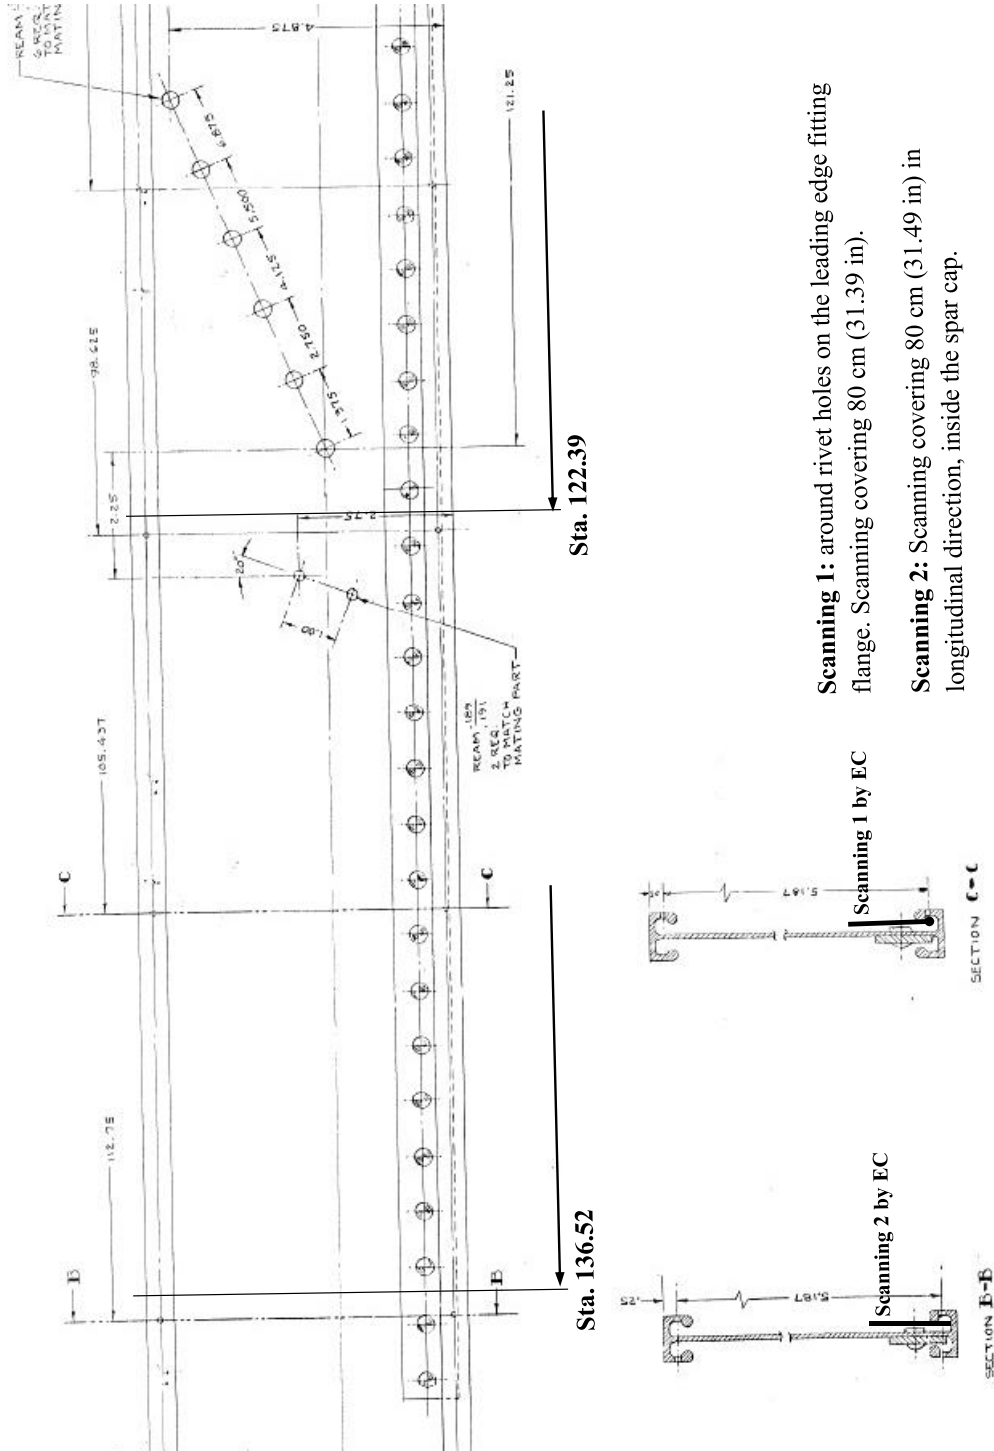
Figure 7D – Spar Caps Location (Cont.)

Scanning 1: around rivet holes on the leading edge fitting flange. Scanning covering 80 cm (31.39 in).

Scanning 2: Scanning covering 80 cm (31.49 in) in longitudinal direction, inside the spar cap.

ACCESS COVER N° 6 - LOWER SPAR CAP

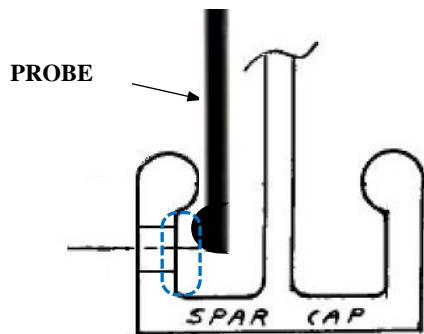
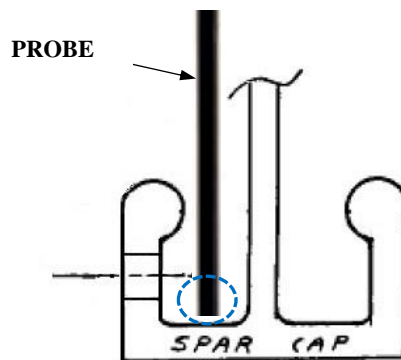
Figure 7E –Inspection areas and scanning

E. The actual scanning of the areas to be inspected, as shown in **Figure 7E**, should cover 80 cm (31.49 in) especially around the holes, gouges, scratches and dents, and corrosion pits.

Scanning 1: around rivet holes on the leading edge fitting flange. Scanning covering 80 cm (31.39 in).

Scanning 2: Scanning covering 80 cm (31.49 in) in longitudinal direction, inside the spar cap.
