Civil Aviation Authority
**EMERGENCY
AIRWORTHINESS
DIRECTIVE**

Number: G-2024-0001-E

Lindstrand Technologies Limited

ATA - Hot Air Balloons - Envelopes with Polyester Filled Aramid (Kevlar) Load Tapes – Removal from Service

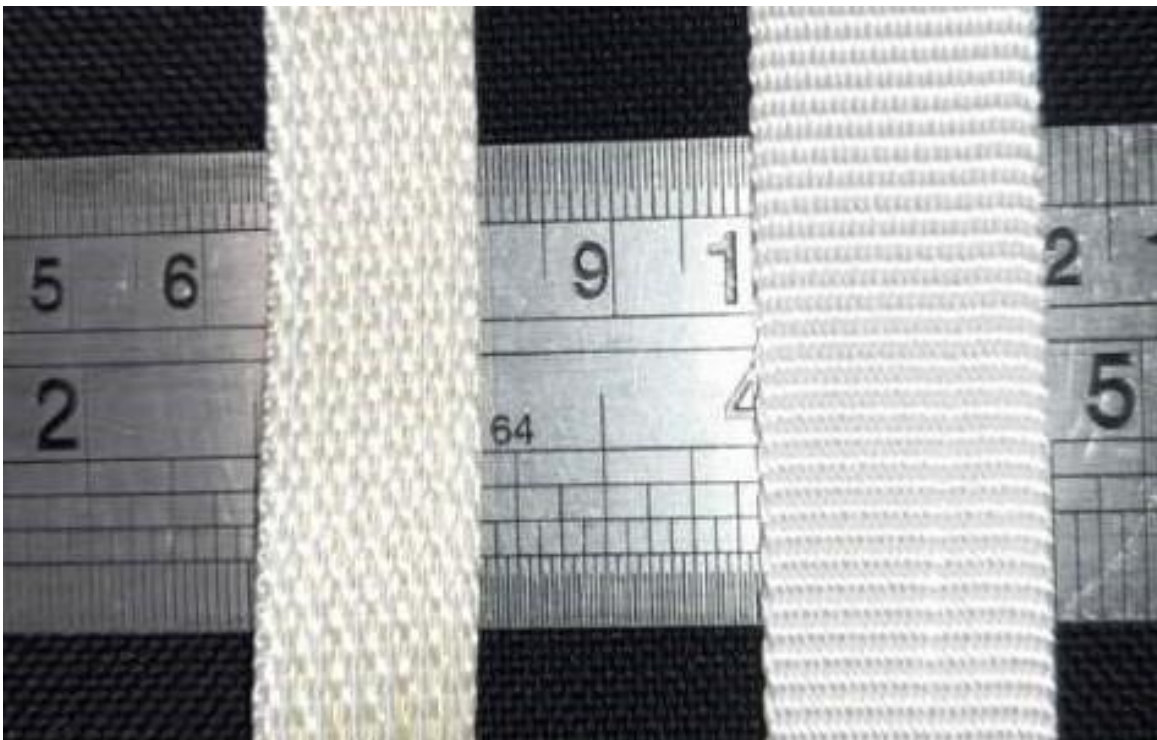
The Polyester Filled Aramid (Kevlar) load tapes (shown on left) is 15 mm wide; the standard polyester tape is 20 mm wide.

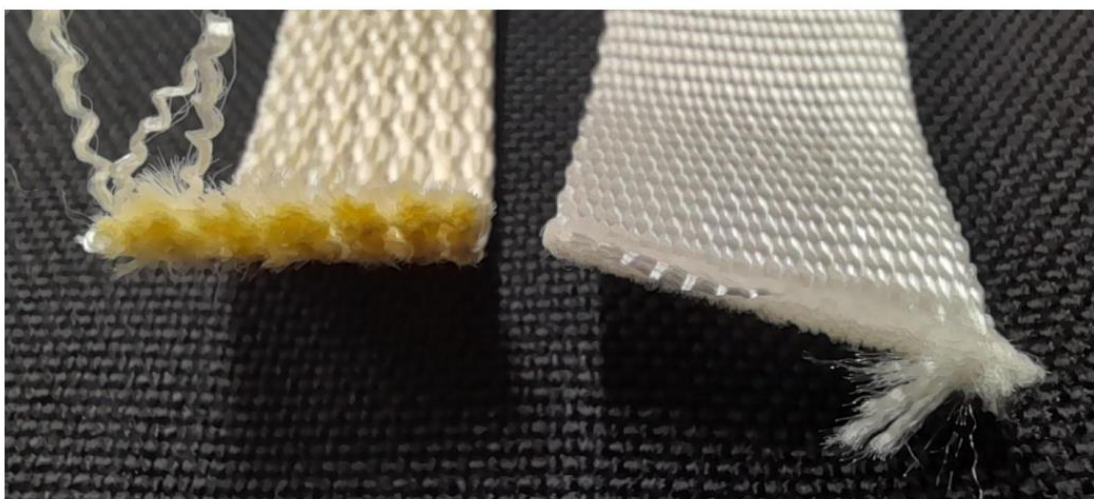
Annexe 1 : Identification des rubans de charge en polyester aramide (Kevlar)

Les rubans de charge en polyester aramide (Kevlar) (illustrés à gauche) ont une âme distinctive qui sera visible en cas de dommage.

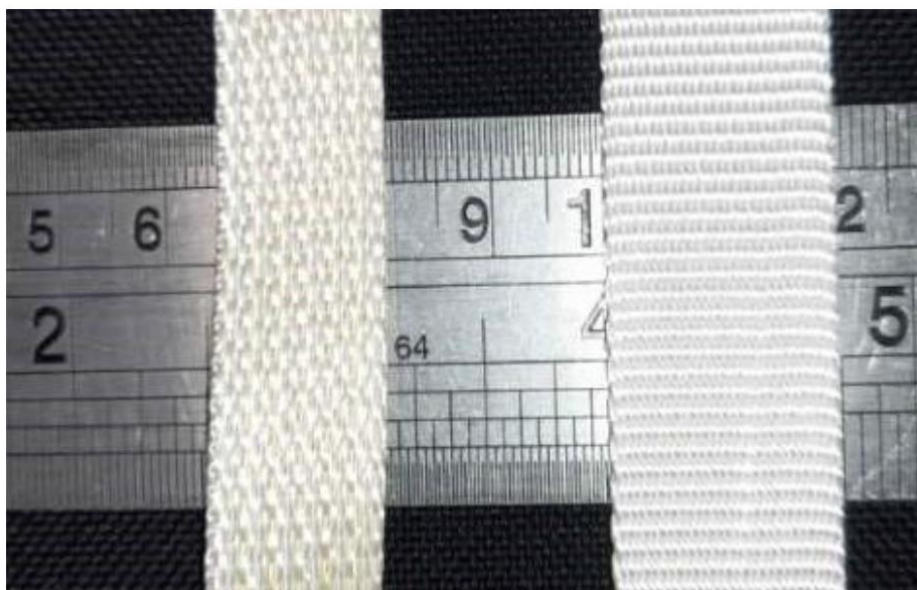
Le ruban de charge en polyester aramide (Kevlar) (illustré à gauche) a une largeur de 15 mm ; le ruban standard en polyester a une largeur de 20 mm.
