AIRWORTHINESS DIRECTIVE	
Date: 12-18-2024	DA RA N° 2024- 05-01 R1	
<p>THIS AIRWORTHINESS DIRECTIVE, DEVELOPED AND ISSUED BY THE AERONAUTICAL CERTIFICATION DEPARTMENT, OFFICE OF AIRWORTHINESS, PURSUANT TO THE PROVISIONS OF ACT N.º 17285, AERONAUTICAL CODE OF THE REPUBLIC OF ARGENTINA, AND PUBLISHED IN THE OFFICIAL GAZETTE ON MAY 23, 1957 CONTAINING THE MODIFICATIONS SUBSEQUENTLY ADDED AND AIRWORTHINESS REGULATIONS, DNAR PART 39, IS APPLICABLE TO ALL AIRCRAFT OF THE SAME MAKE AND MODEL REGISTERED IN THE NATIONAL AIRCRAFT REGISTRY. AN AIRCRAFT TO WHICH A DA IS APPLICABLE MAY NOT BE OPERATED EXCEPT IN ACCORDANCE WITH THE REQUIREMENTS OF SAID DA.</p>		
APPLICABILITY		
Manufacturer LAVIA SA	Aircraft Type-Model PA25 / PA25-235 / PA25-260, INCLUDING AIRCRAFT MANUFACTURED BY PIPER, CHINCUL, LAVIASA and FAdE SA	
Revision	Revision 1	
Superseded document	This Airworthiness Directive supersedes DA RA N° 2024-05-01, Original Revision.

Reason for revision	The purpose of this revision is to incorporate instructions under APPENDIX 1 to conduct an Eddy Current NDT Inspection in specific areas of the PA-25 front wing spar, to comply with item 2b) of this Airworthiness Directive.	
Subject	Corrosion f

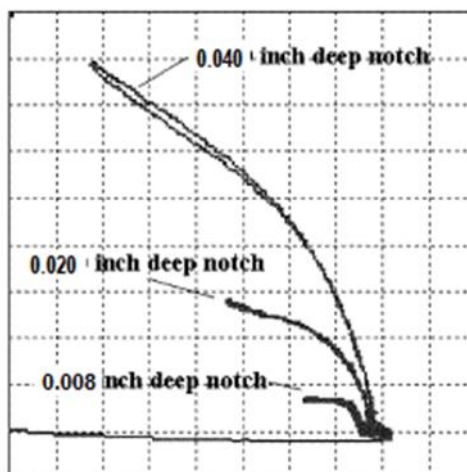
Figure 4E –Type Sensitivity Verification Signal (aluminum)

- E. Check now the sensitivity of the inspection configuration by placing the probe on the **RS0824-2024T3** standard by means of a non-conducting belt in the standard (if needed), scan the **0,008 in**, **0,020 in** and **0,040 in** deep reference notches. Responses should be like those of **Figure 4E**.

NOTE: A 0,005-notch response should produce a minimum of FSH 5% in a vertical response (half of a grid division) and be clearly differentiated from the reference noise.
