EASA considerations, leading to the decision not to adopt Federal Aviation Administration (FAA) AD 2020-26-16

[Docket No. FAA-2018-1046; Product Identifier 2018-CE-049-AD; Amendment 39-21371; AD 2020-26-16]

Airworthiness Directives; Piper Aircraft, Inc. Airplanes

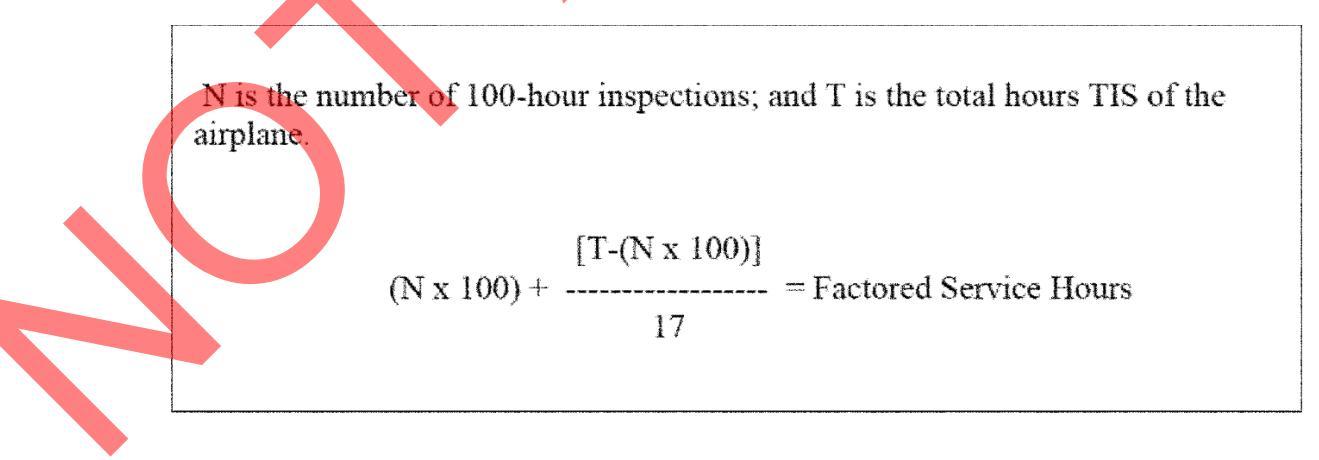
Figure 1 to paragraph (h)(2)

(2) Before further flight after completing the action in paragraph (h)(1) of this AD, calculate the factored service hours for each main wing spar using the formula in figure 1 to paragraph (h)(2) of this AD. Thereafter, after each annual inspection and 100-hour inspection, recalculate/update the factored service hours for each main wing spar until the main wing spar has accumulated 5,000 or more factored service hours.

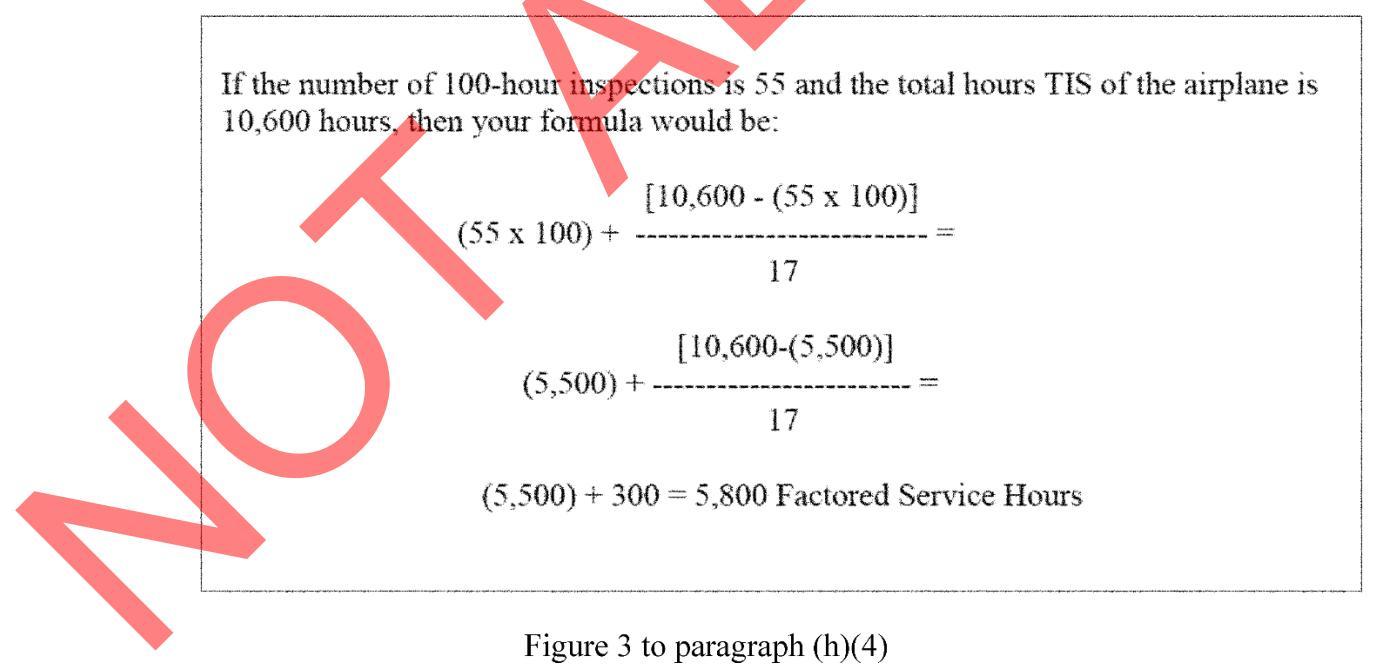
(4) An example of determining factored service hours for an airplane with both 100-hour and annual inspections is as follows: The airplane was originally flown for personal use, then for training for a period of time, then returned to personal use. The airplane maintenance records show that the airplane has a total of 10,600 hours TIS, and fifty-five 100-hour inspections for purposes of compliance with § 91.409(b) have been done. Both main wing spars are original factory installed. In this case, N = 55 and T = 10,600. Use those values in the formula shown in figure 3 to paragraph (h)(4) of this AD. First, calculate commercial use time by multiplying (N x 100). Next, subtract that time from the total time, and divide that quantity by 17. Add the two quantities to determine total factored service hours. In the example in figure 3 to paragraph (h)(4) of this AD), the eddy current inspection would be required because the factored service hours are more than 5,000 hours.
